Hello everyone, today I'm going to give you a tour on Khobi-II, which in reality pronounced Jobi, and as you know is a hydropower plant located in Georgia.

I'm the deputy project manager for this project that started back in February 2021.

Khobi-II is a run-off-the-river hydropower project, that starts with an intake on the river Khobi.

Let's get into business, and let's talk about the Technical Challenges we have been facing as Owners Engineers*

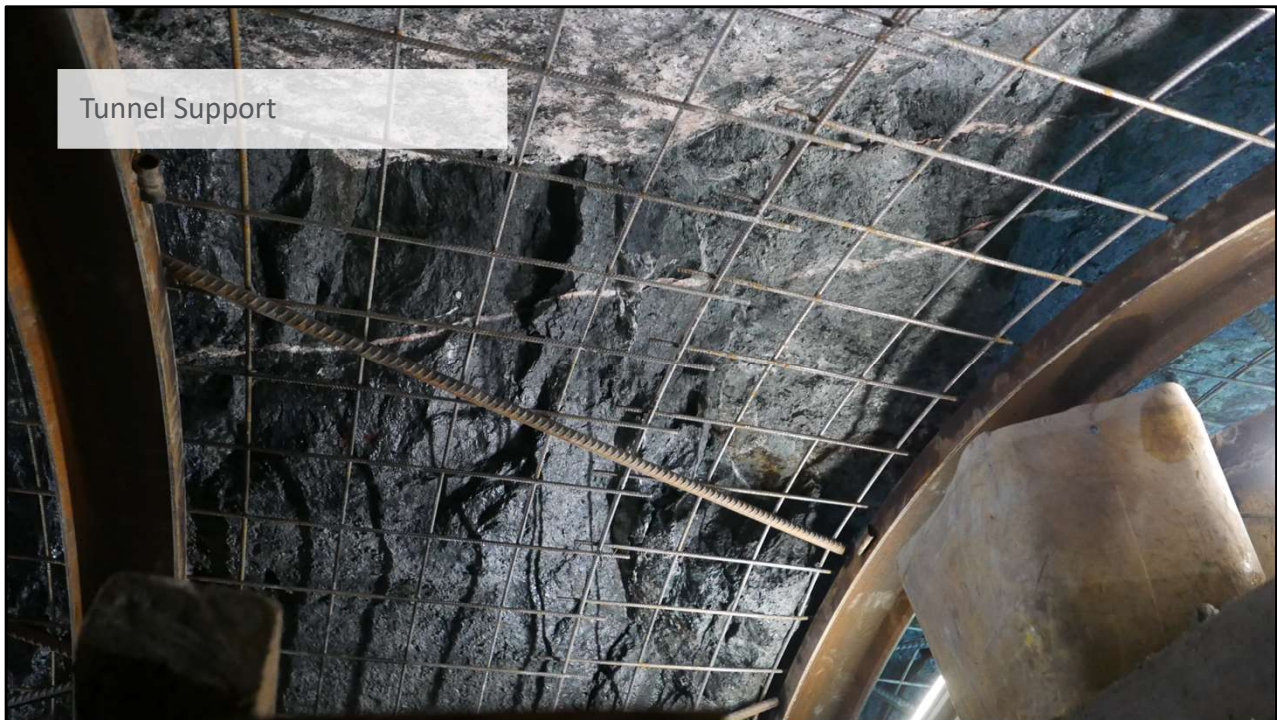
The first one is that they didn't install a primary support to the tunnel, which as you can imagine is far from ideal.

This was due the incentives from the Contractor to its staff, they promised a bonus for finishing the excavation only, not the whole package including the support, that again, is far from ideal.

In the picture Here you can see the crown of the tunnel, with a mesh that is meant to hold any loose material that may fall off.

The mesh, the weight of the material and the contraction of the tunnel itself is supported by the steel ribs seen here.

As you can imagine, the steel ribs are under a lot of stress and need a proper foundation*

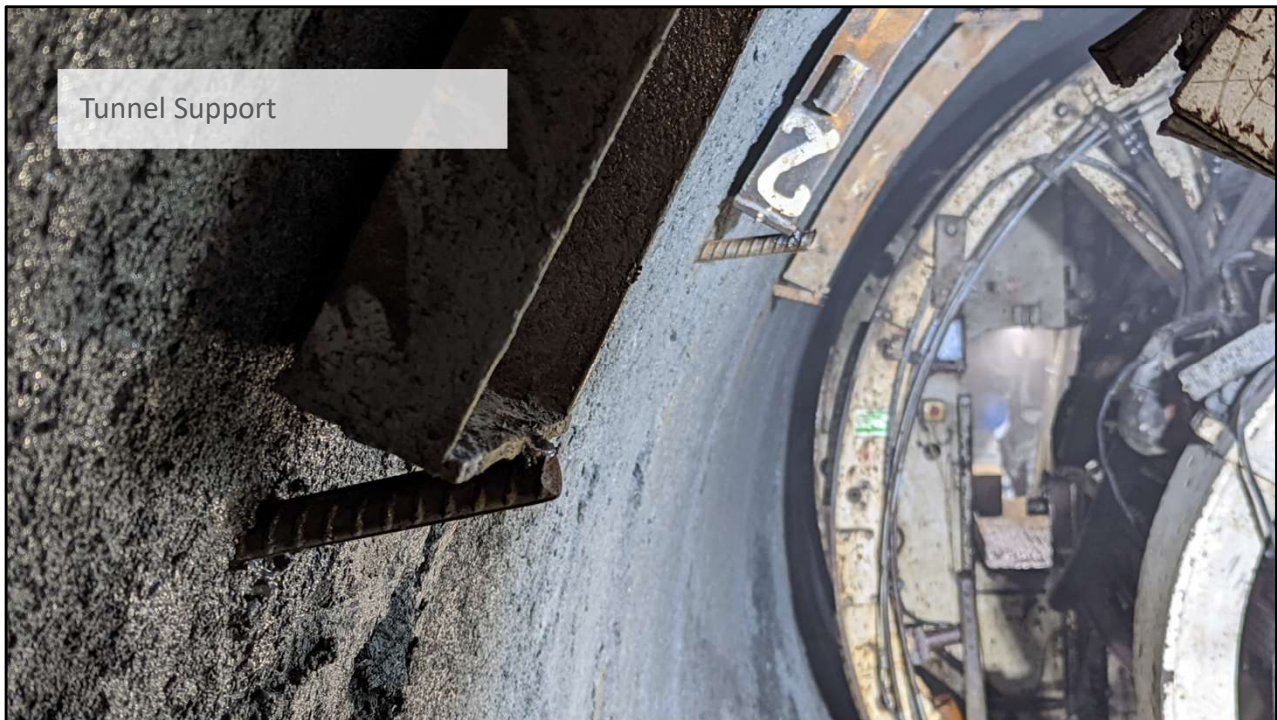
Well, here they are, the foundations of the ribs. Nothing else than rebar in the wall.

As you are imagining, again, far from ideal.

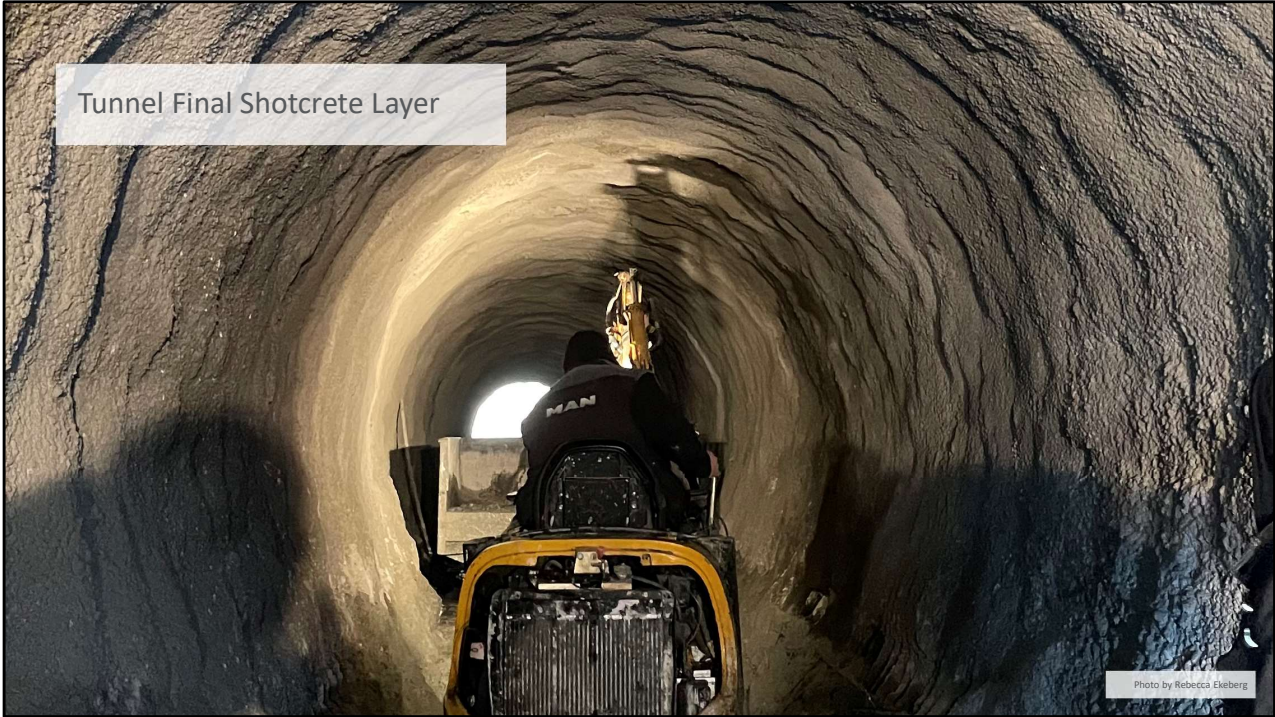
Talking about shotcrete, since it is so difficult to manoeuvre inside the shotcrete finish has been substandard as we can see in the picture *

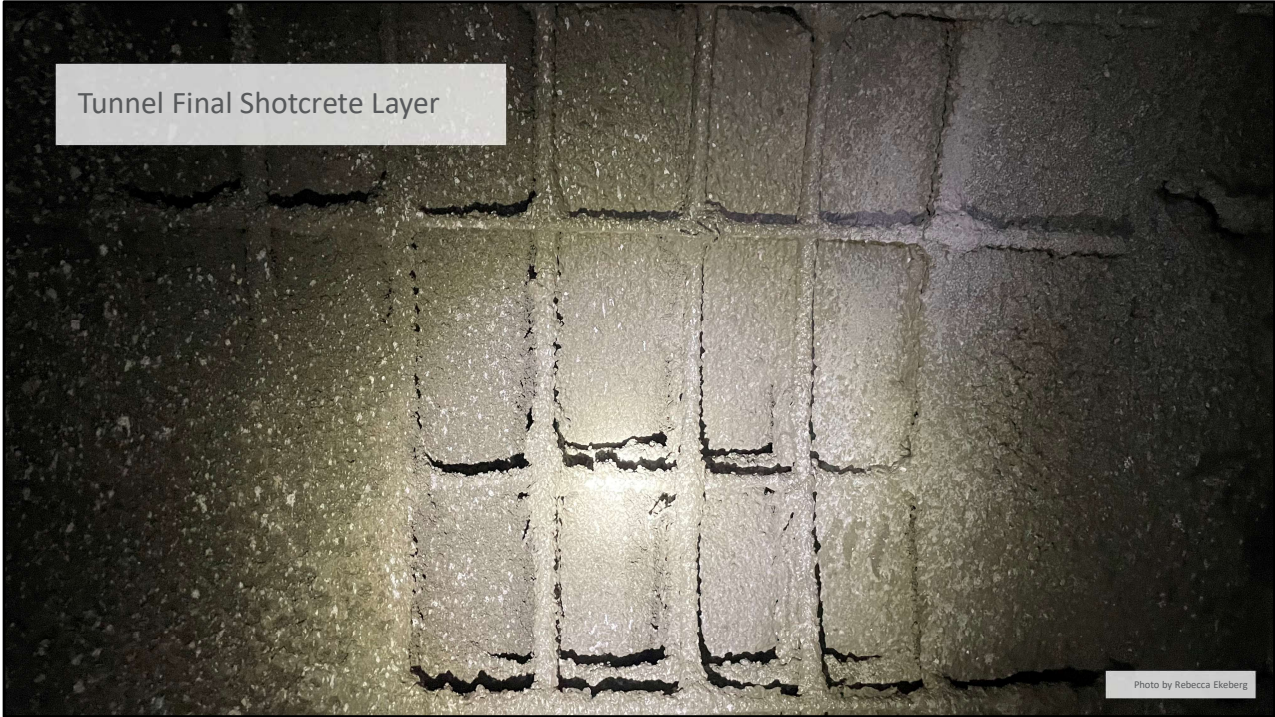
Or completely inadequate as you see here.*

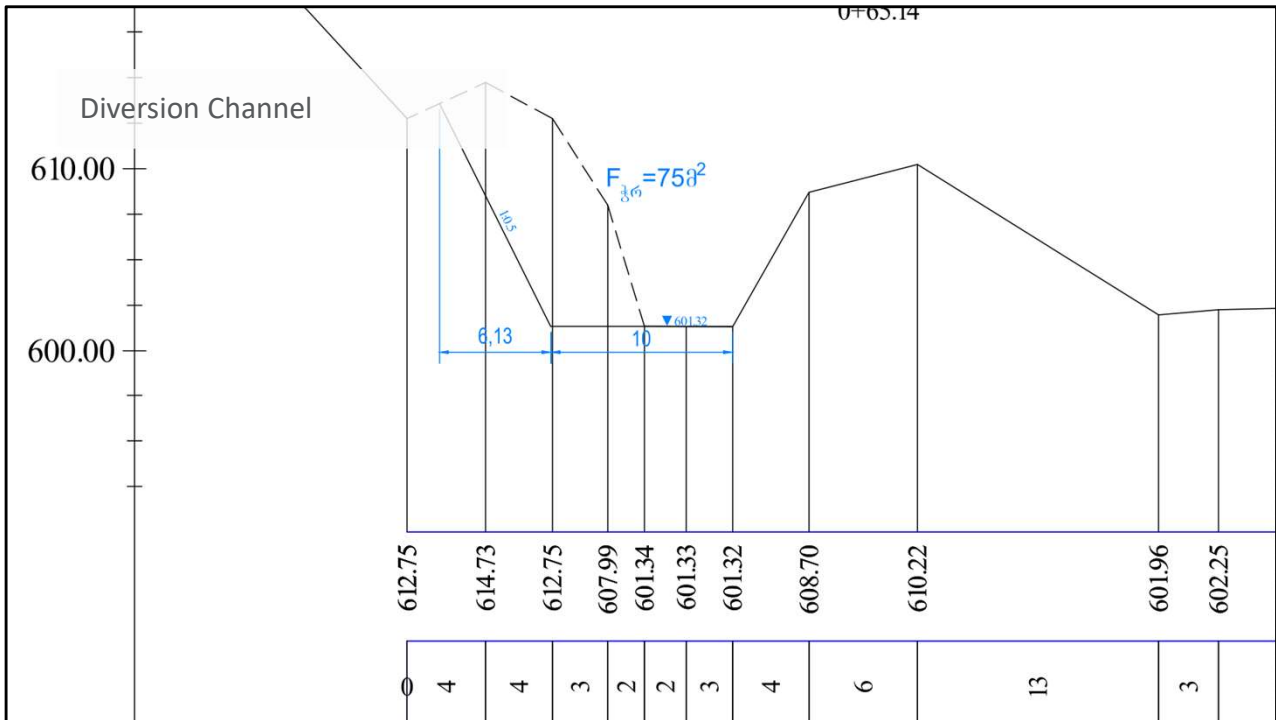
Here you can see a typical cross-section of it, with a trapezoidal channel, very common, considering 10 m in base width.

We believe this section was not enough and issued some recommendations to either increase the capacity of the channel or raise the cofferdam height.

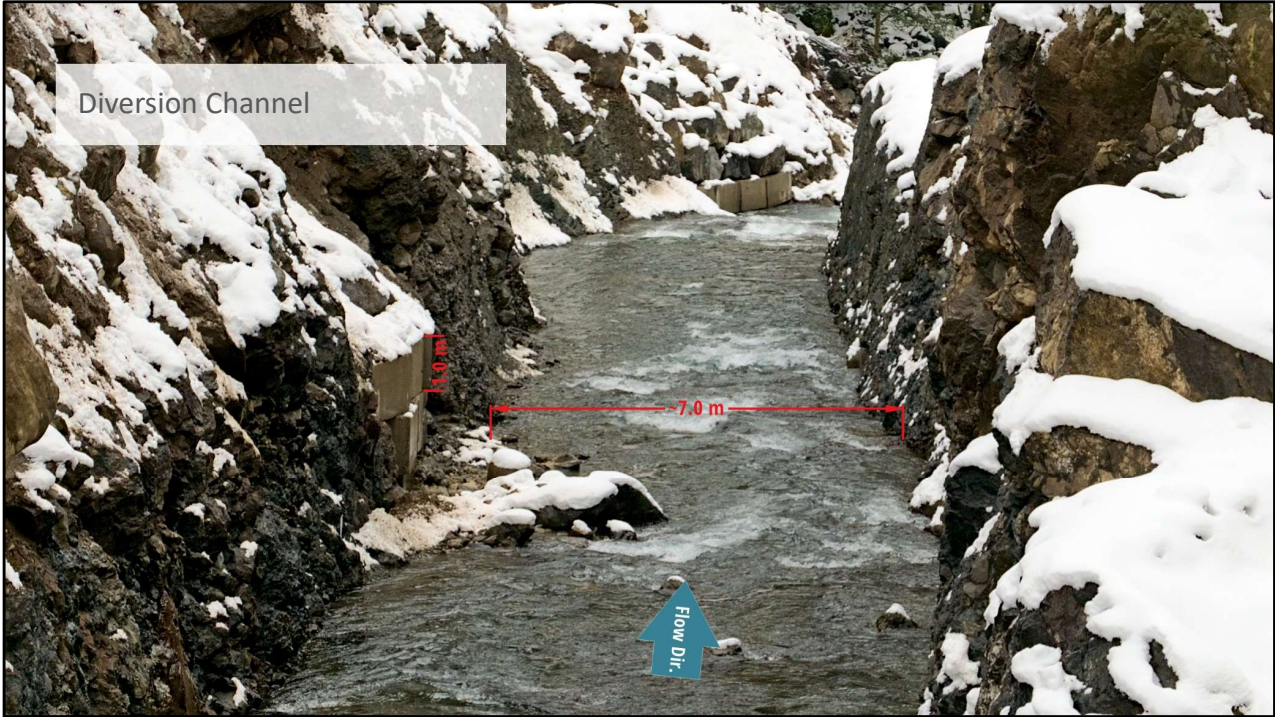
We realised the channel was not built according to their drawings...

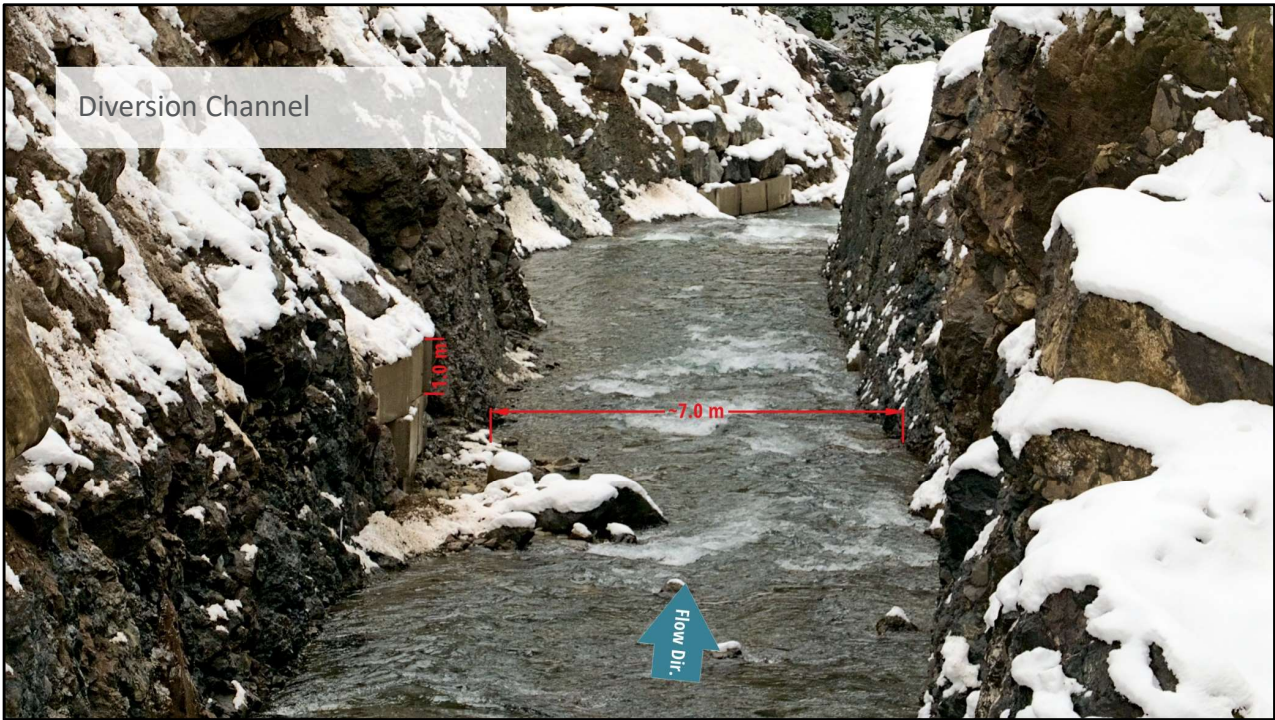
We realised the channel was not built according to their drawings... *

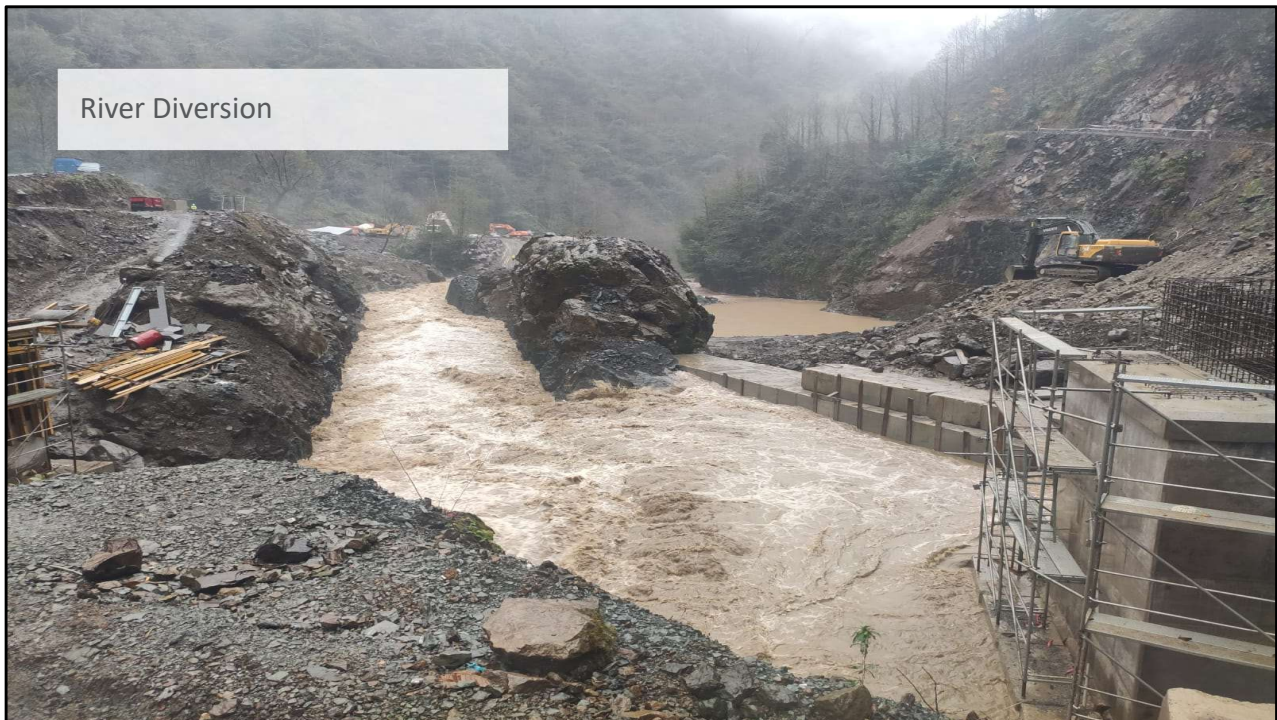
In the meantime, they had a couple of flood events that as you can see couldn't be handled by the diversion system.

After a lot of pushing and hunting, the Contractor managed to send us a topographical survey of the headworks area that allowed us to make a proper hydraulic analysis of the diversion system and back engineer the this flood event you see in the picture*

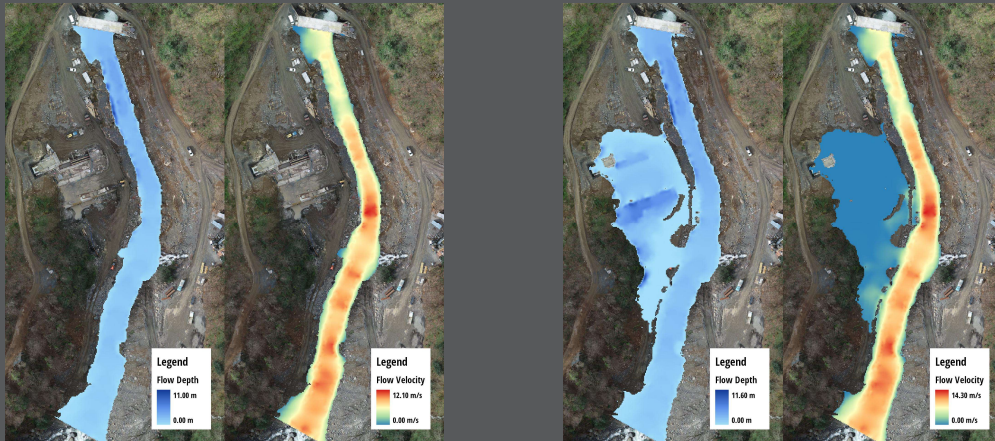
Flood Events Tr = 2 yr. (Left) vs Tr = 5 yr. (Right)

On the left you could see what would happen for a return period of 2 years, while on the right for 5 years.

This result was interesting because it gave us a couple of insights:

- The cofferdam, which we believe was too low ended up being ok.
- The flooding of the construction area was going to happen from the downstream end*

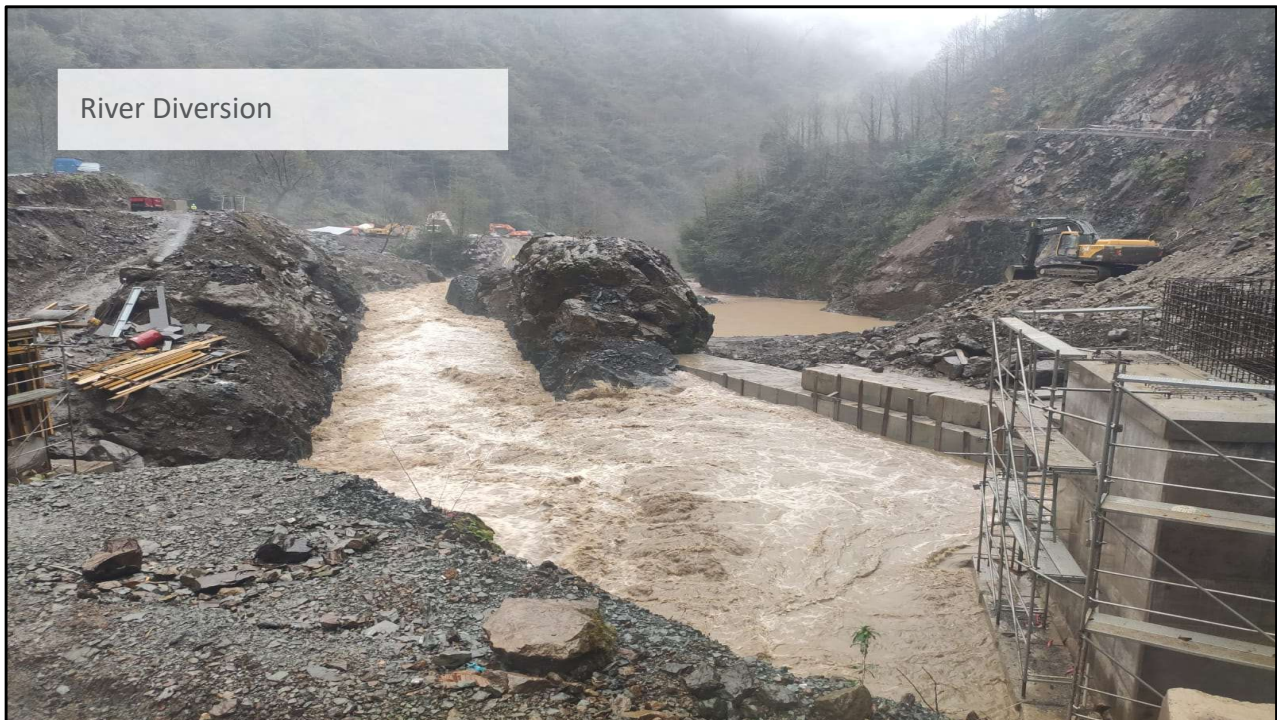
And what about this flood event?

It ended up being a 3.6 years return event.

Well under our recommendation of 8.5 years*

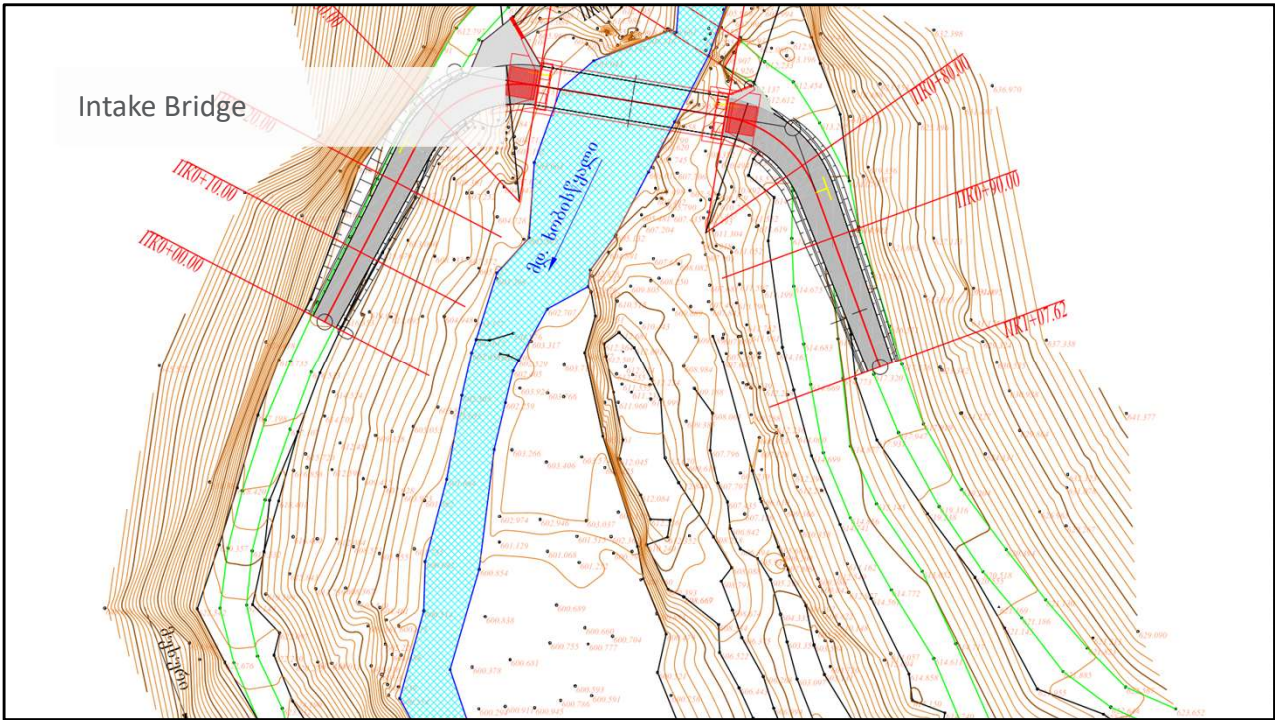
When we received the drawings of the bridge, we almost immediately noticed something in them, can you see it?

There is no headwork in the drawings. The river is flowing as it does in its natural state*

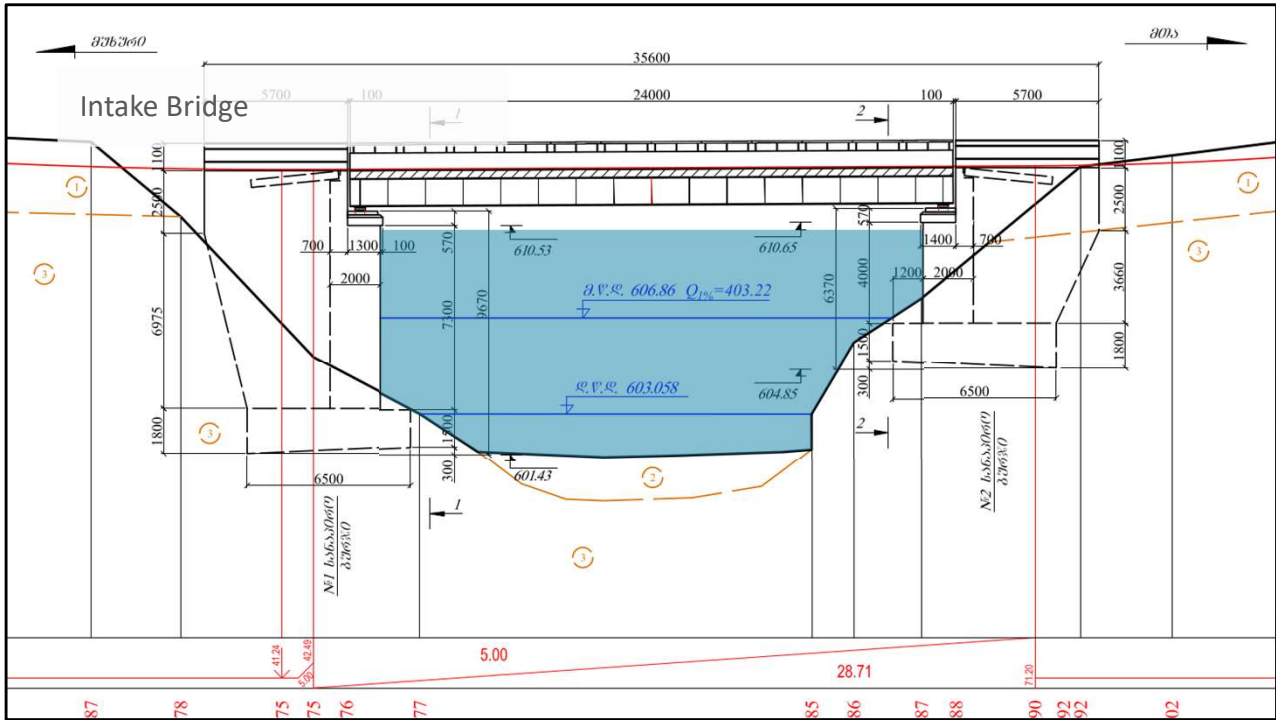
Nevertheless, when the headwork is finished and working, this will be the normal water level in the small reservoir upstream of the intake.

Less than a meter between the water surface and the bridge bearings

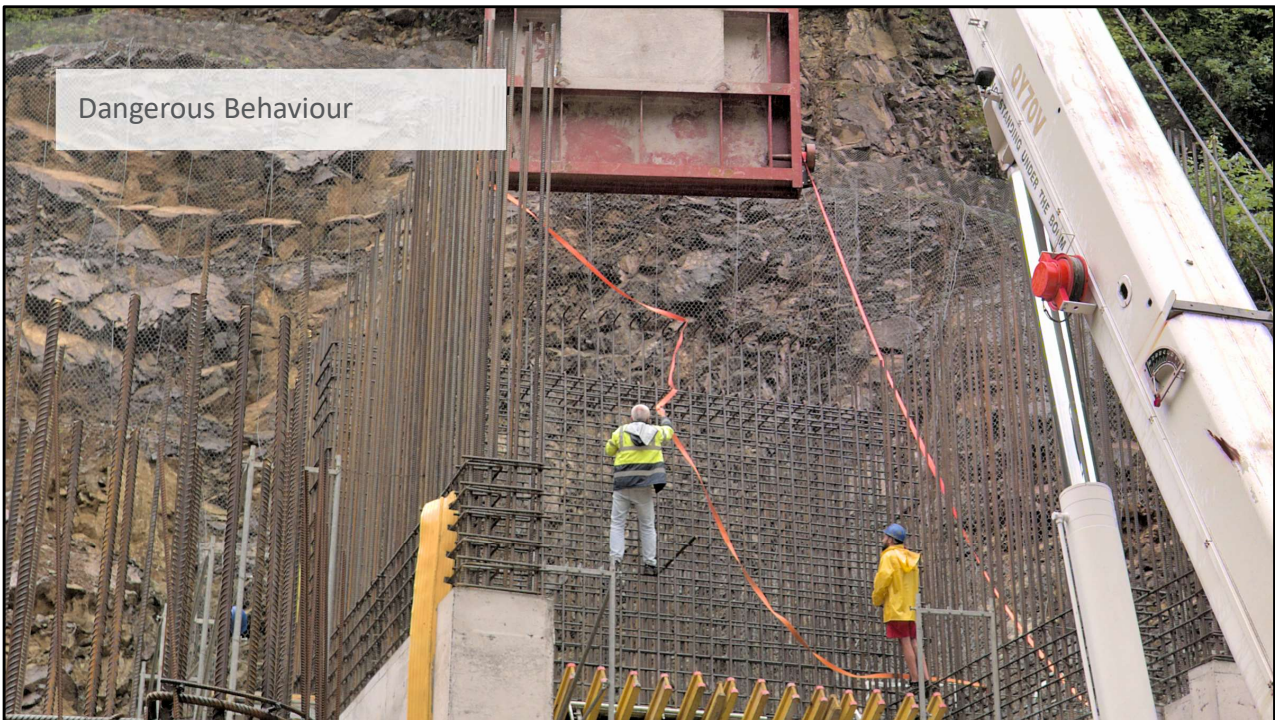
Georgians (at least the ones we have worked with) are not used to comply with international H&S standards that may look obvious and usual to us.

For example, here you can see workers without any harness or PPE whatsoever working on heights, hanging from one hand and using the other to move a very heavy gate.*

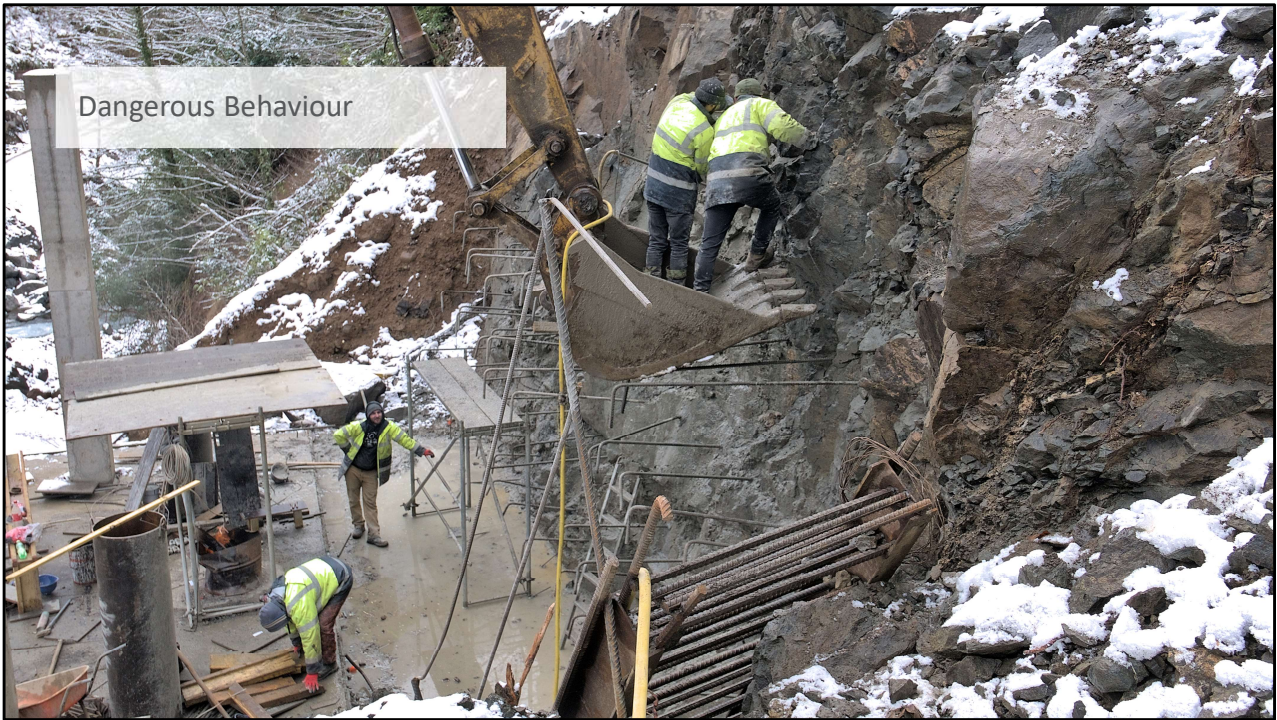
Similar to the one before, they were installing rockbolts on a slope without any PPE or harness whilst inside an excavator bucket!

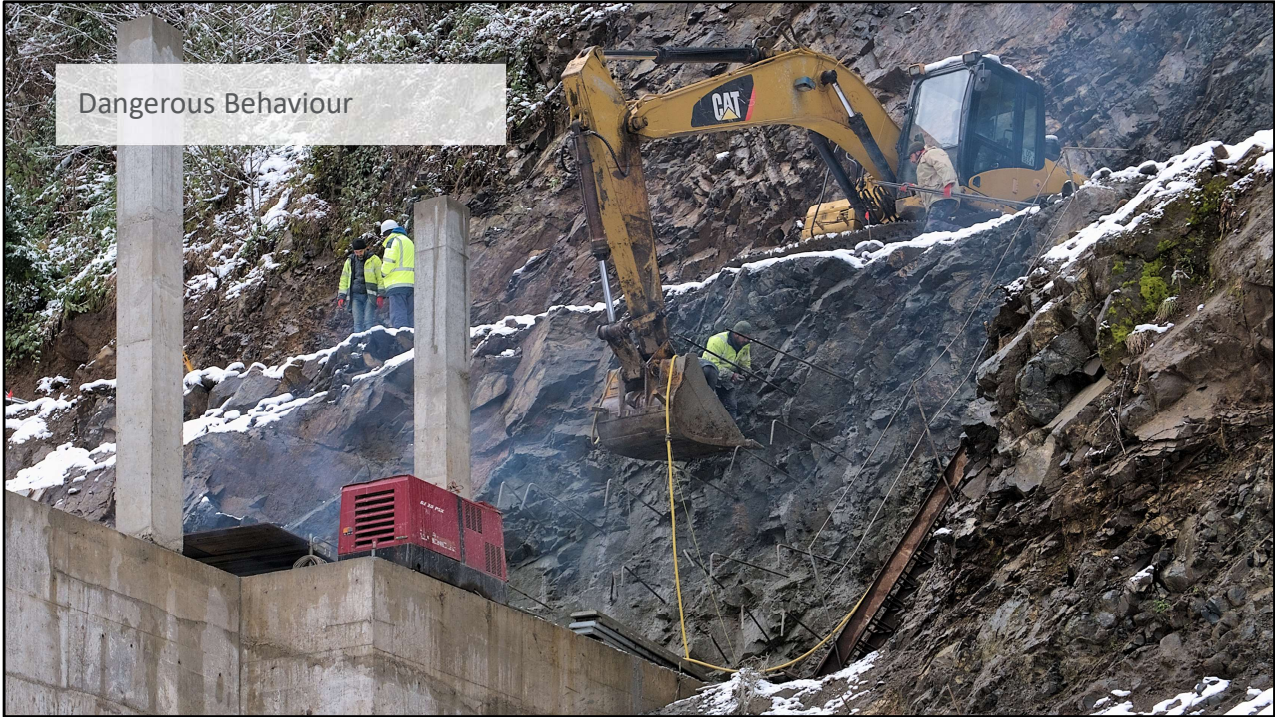
They were doing this in from of the Contractor H&S manager who seem pretty ok with what was going on.*

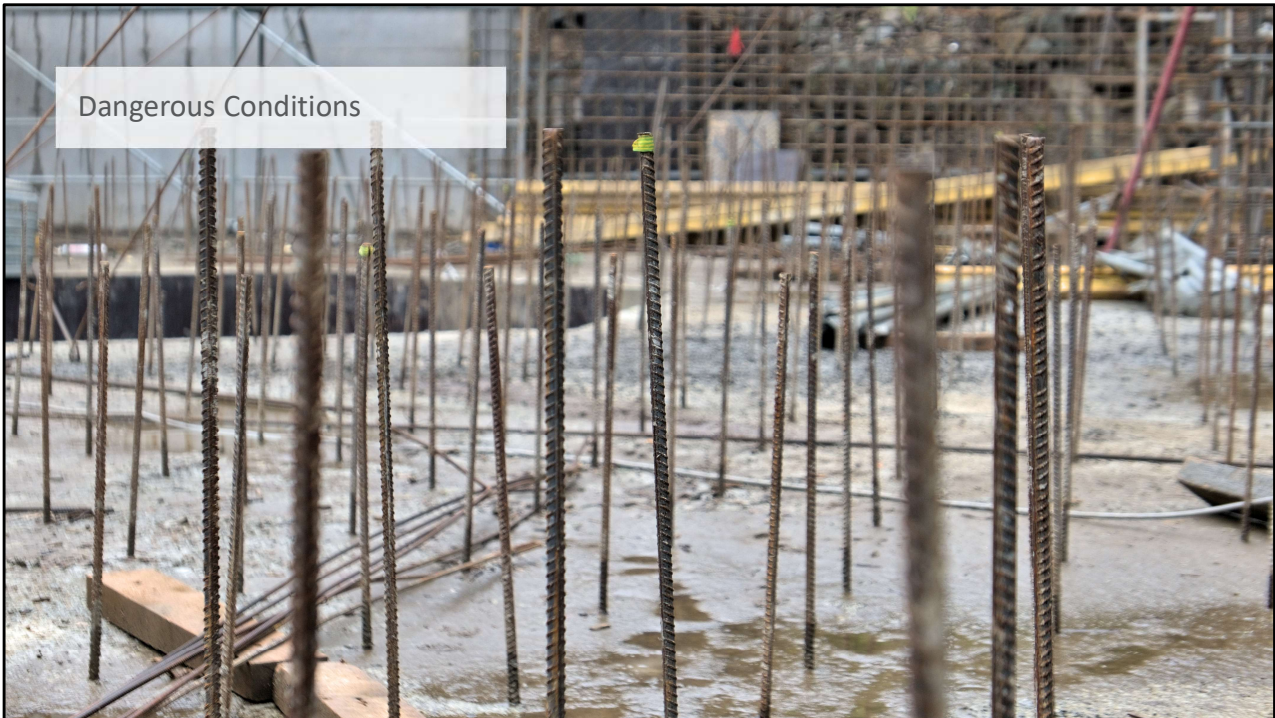
The powerhouse was no exception.

As you can see the floor of the powerhouse was a minefield of vertical rebars with rubbish in between, creating a truly dangerous place to work or even walk.
