EFFECTS OF COMPOSITION AND TEXTURE ON STRENGTH OF ANHYDRITE CAPROCK

Implications of lateral variations for long-term CO₂ storage

S. Hangx^{1,2}, C. Spiers², A. Ten Hove², A. Pluymakers² Work preformed at the High Pressure and Temperature Lab

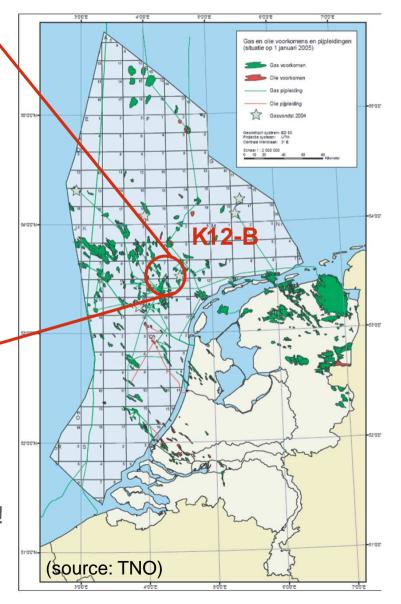
ANHYDRITE CAPROCK THE NETHERLANDS

Anhydrite – Basal unit Zechstein Group $CaSO_4 + CO_2 + H_2O \leftrightarrow CaCO_3 + H_2SO_4$

Of interest to the Netherlands, but also to the USA (Teapot Dome), Canada (Weyburn) and Middle East!

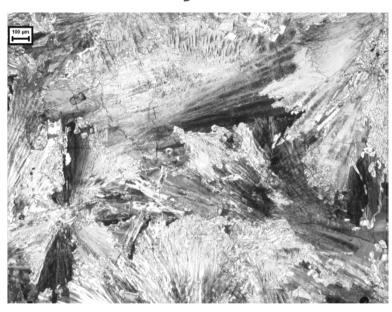
Acicular anhydrite

- <u>Bimodal distribution:</u>
 acicular grains (60%), d = 1000-2000 μm;
 matrix (40%), d < 50 μm
- 15-25 wt% dolomite
- $\Phi = 0.1-0.3\%$
- $\kappa < 10^{-21} \text{ m}^2$

Irregular grains; bimodal *d*-range; $d = 1000 \mu m$

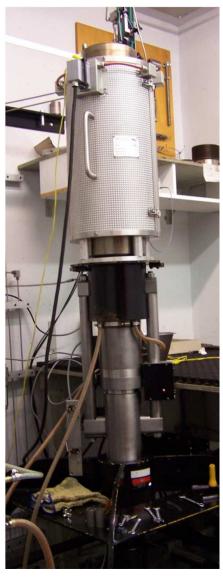
EXPERIMENTAL METHODS COMPRESSION EXPERIMENTS

- $P_c^{\text{eff}} = 1.5 50 \text{ MPa}$
- $P_f = 0 15 \text{ MPa}$
- fluids: CaSO₄/ CO₂-saturated solution
- *T*= 80°C
- $\dot{\varepsilon} = \sim 10^{-5} \text{ s}^{-1}$

$$\sigma_2 = \sigma_3 = P_c$$

peak stress:

differential stress at which failure/ loss of strength occurs

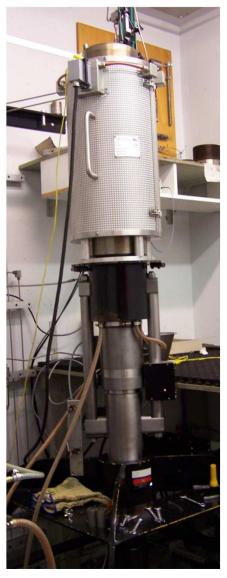
EXPERIMENTAL METHODS HYDROFRACTURING EXPERIMENTS

- $P_c = 3.0-15.0 \text{ MPa}$
- $\Delta \sigma_{\text{initial}} = \sigma_{1,\text{initial}} \sigma_{3,\text{initial}} = 13.5-93.6 \text{ MPa}$
- *T*= 80°C
- Pump rate = ~0.34 µl/ s

$$\sigma_2 = \sigma_3 = P_c$$

pore fluid pressure @ failure; P_p drop
