## **CASE STUDY ON SLOPE STABILITY ALONG FINCHA-LEMLEM-BEREHA ROAD PROJECT**

**Tseday Damtew Worku**

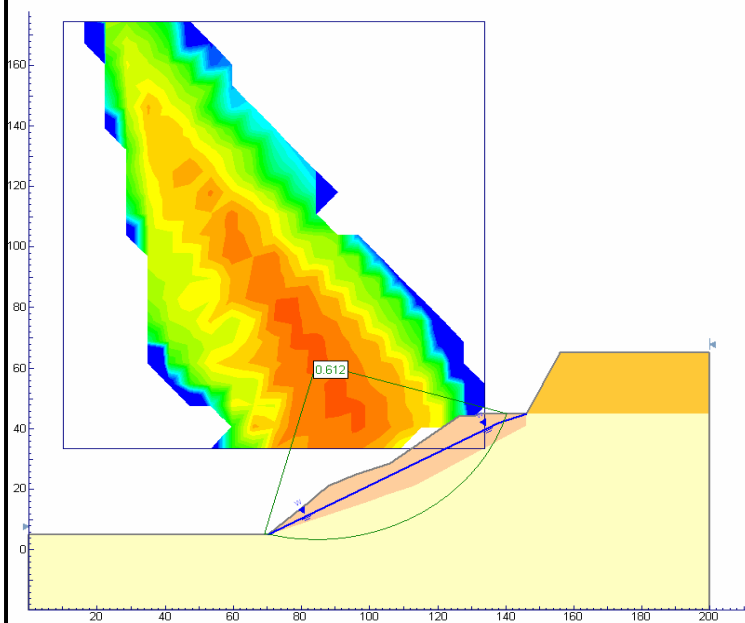
### Section at BH8

- ground after embankment construction
- with pore pressure
- drained analysis
