## **Analyses of a residual soil slope at Addishu area, Tigray, Northern Ethiopia**

This project focuses on slope stability problems in Addishu area, southern Tigray, northern Ethiopia. The study area has an estimated size of 70 square kilometres (14 km length by 5 km width). Landslides in this area have displaced about 120 people, destroyed 75 rural houses and caused major damage on about 11 hectare of agricultural land. However, more than 500 people are still living in terrains potentially endangered by slope instabilities.

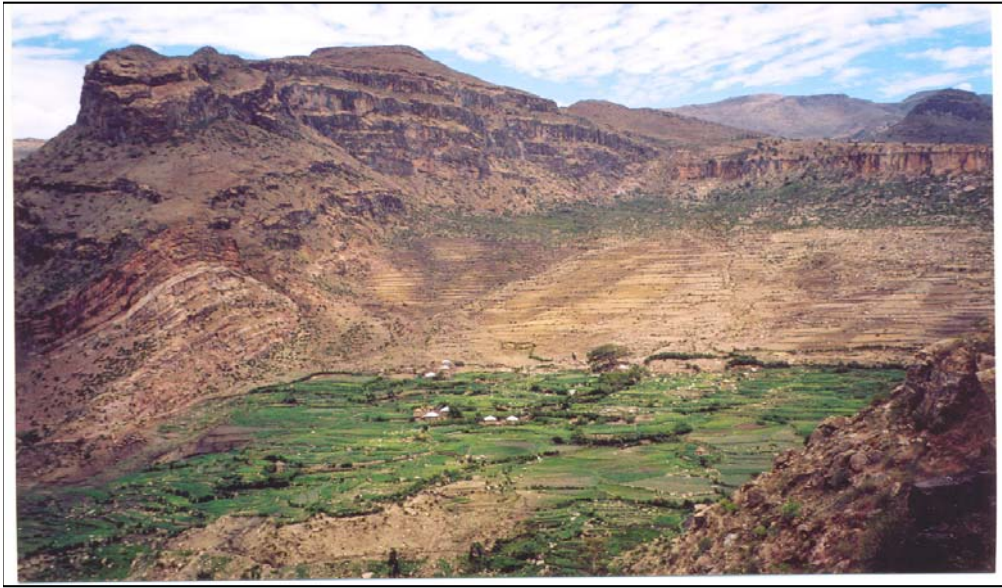
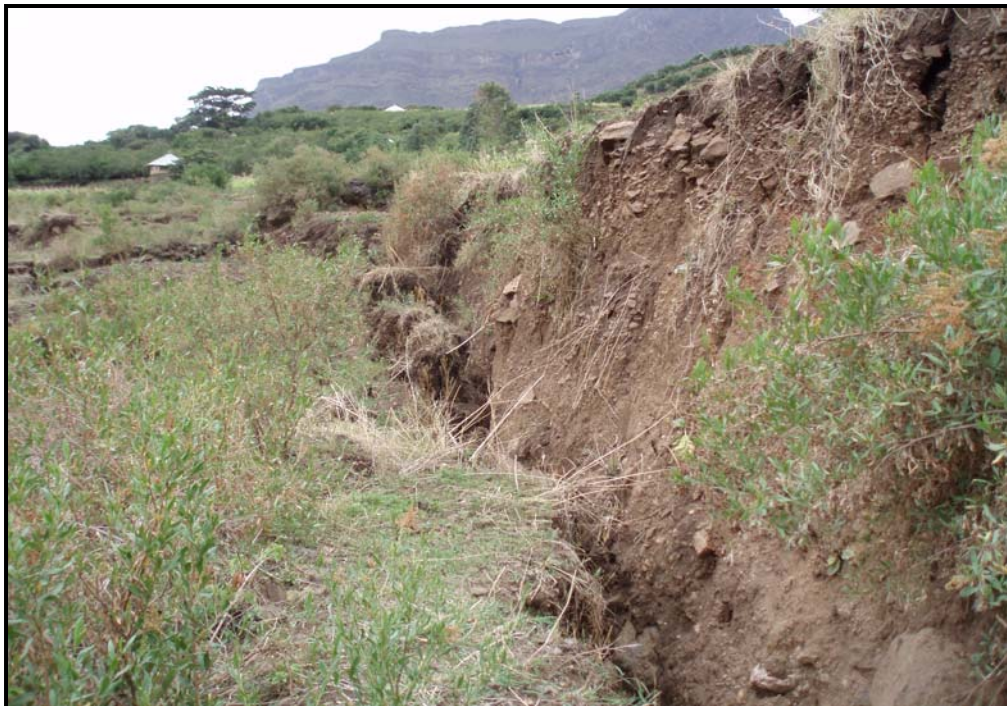
*Fig 1 First part of the slide area*
