LAND SLIDE ALONG TARMABER KOMBOLCHA ROAD: CASE STUDY

ABSTRACT

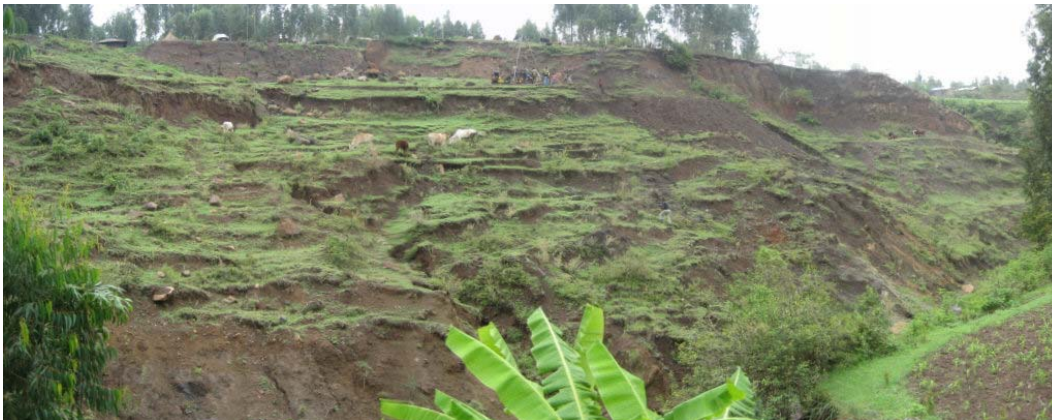
Fig. 1: View of the Slide Area

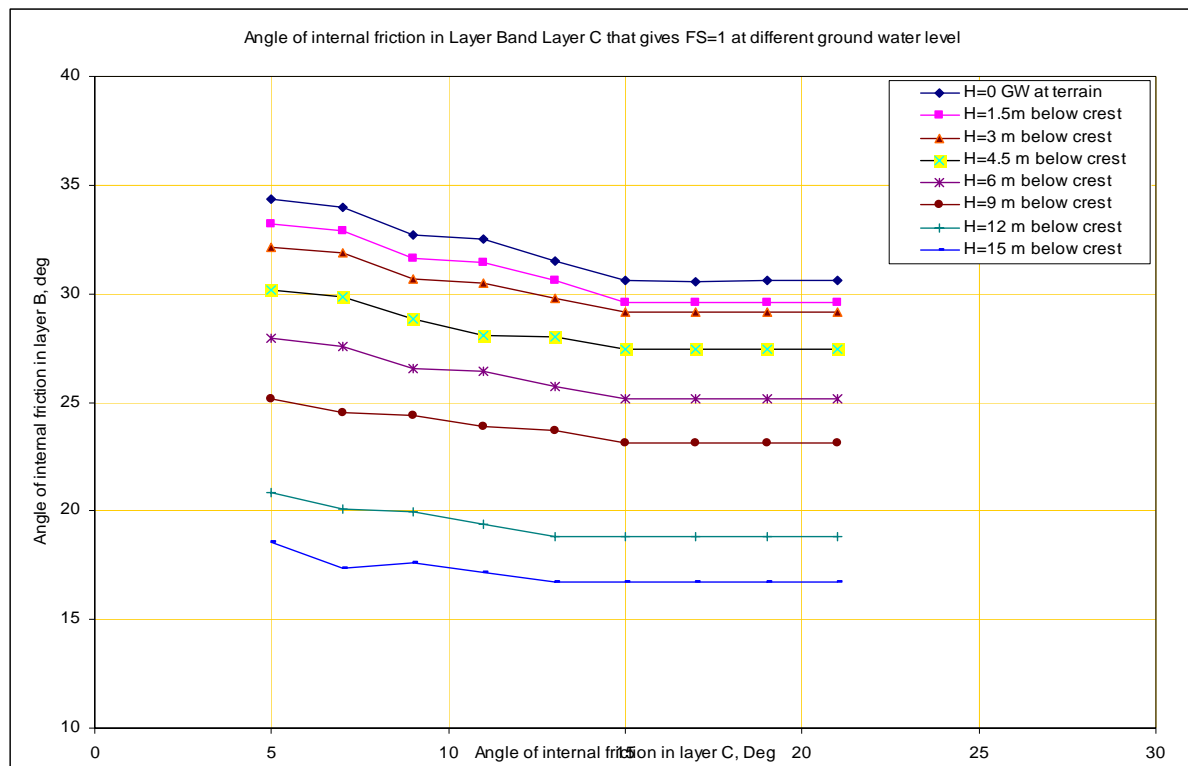
Fig. 4: Back Analysis - Strength parameters that give unit factor of safety at different ground water level

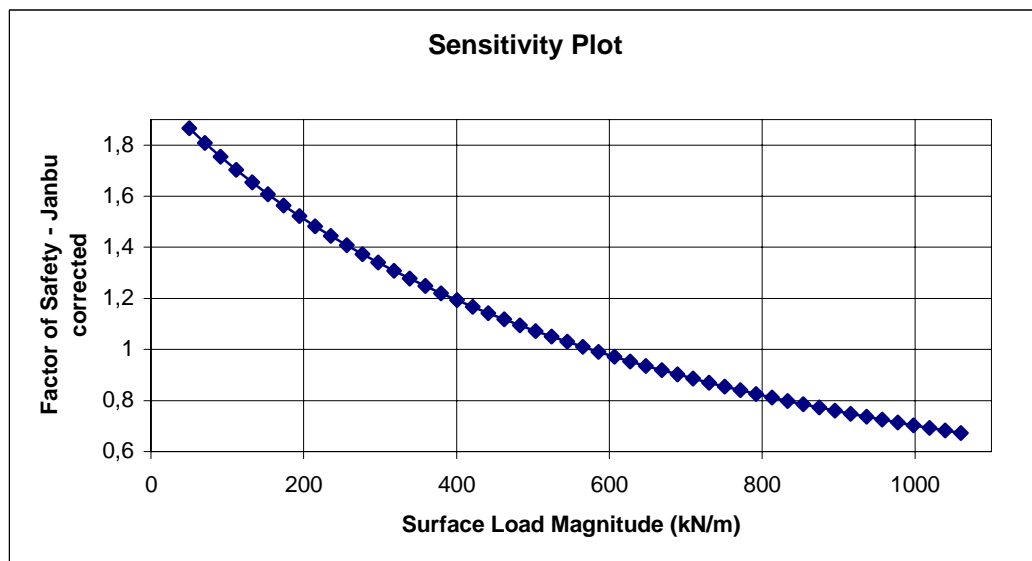
Fig. 5: Analysis results using measured strength parameters - Estimation of surface load that could trigger slide
