Strength of embankments on peat

Cor Zwanenburg

IJkdijk Stabiliteitsexperiment

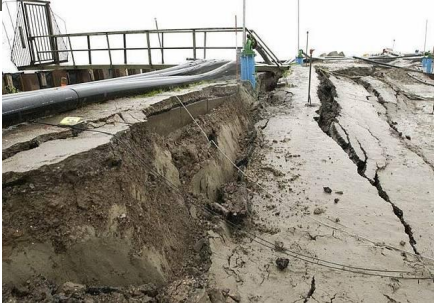
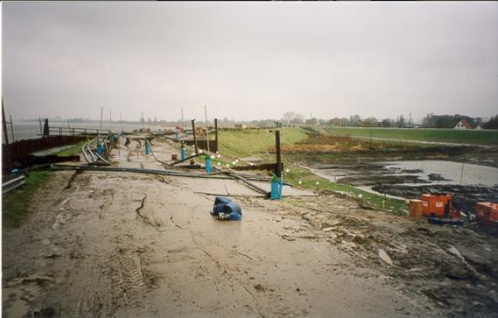
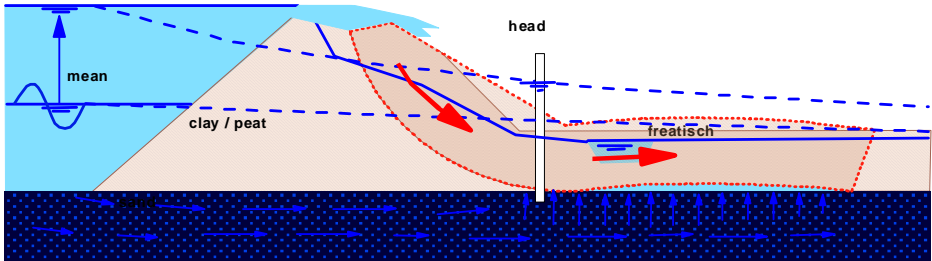
Bergambacht case (2001)

design level

Failure plane

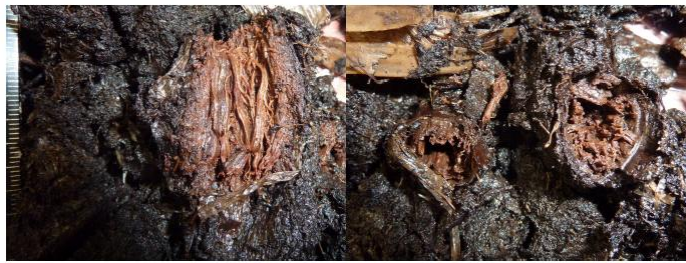
Galigaan,
(*cladium mariscus*)

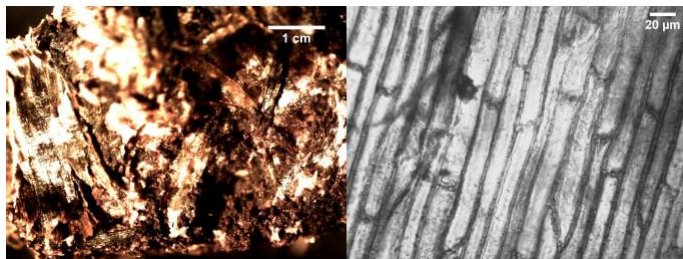
Veenbloembies,
(*Scheuchzeria palustris*)

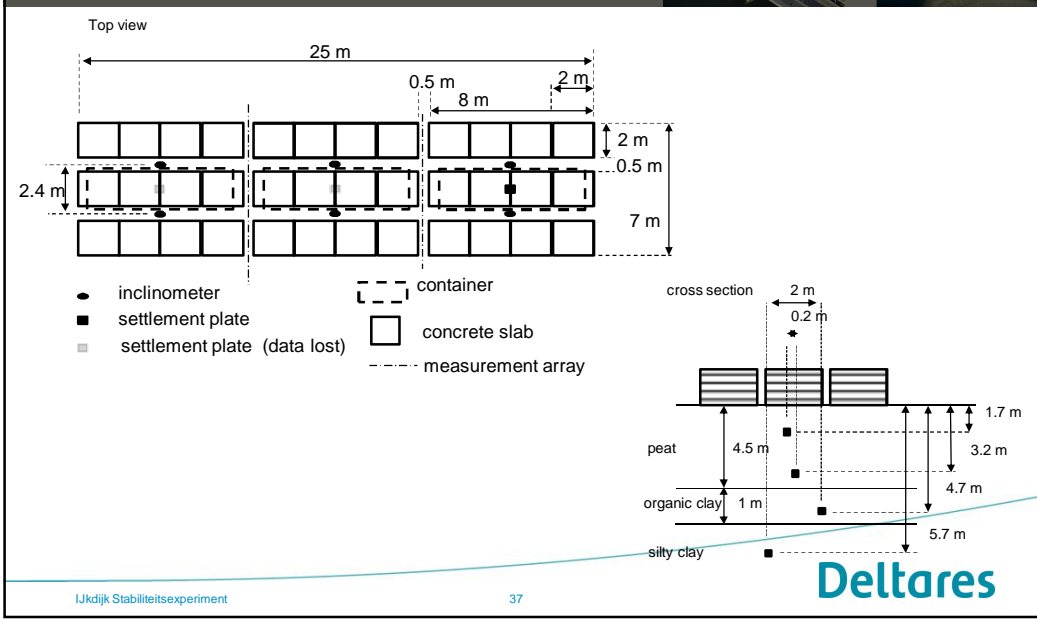
Test 6

1. pre-loading; **10 concrete slabs**, $q = 33 \text{ kN/m}^2$, construction period 56 days

2. Consolidation and creep, 160 days

3. Start application failure load, **10 extra concrete slabs**.

4. Application failure load, placement **containers**.

5. Application failure load, **stepwise filling** the containers.

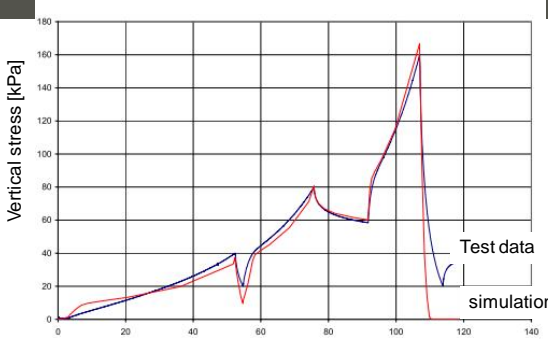
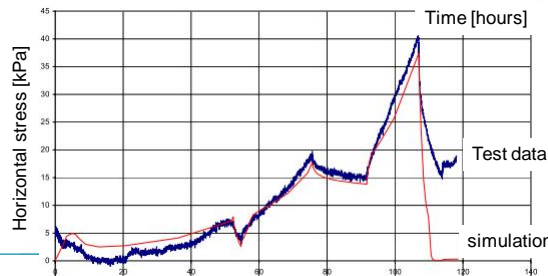
Simulation test 88A SSC-model

κ^* [-]	0,0237
λ^* [-]	0,30
μ^* [-]	0,02
ν [-]	0,15
POP [kPa]	2
M [-]	2,68
K_{0nc} [-]	0,227
ϕ [°]	67,8

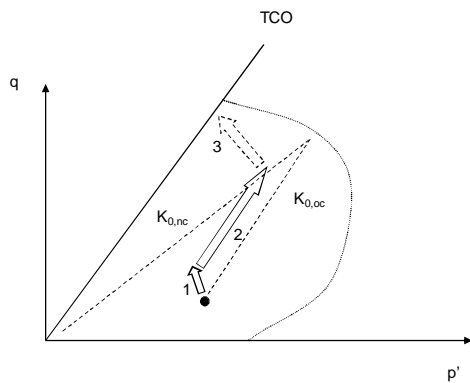
Final element modelling test 1 and 2

problems with very low stresses
problems with tension cut off
problems with modelling over consolidated behaviour, incl. fracturing

hard to reproduce field measurements by FEM

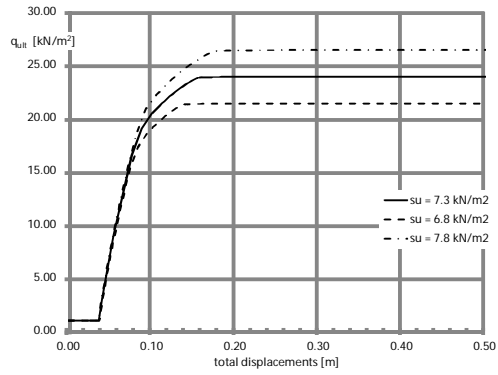
MC simulation of test 2

Failure load
 Test: 23,77 kN/m²
 Simulation: 24,13 kN/m²

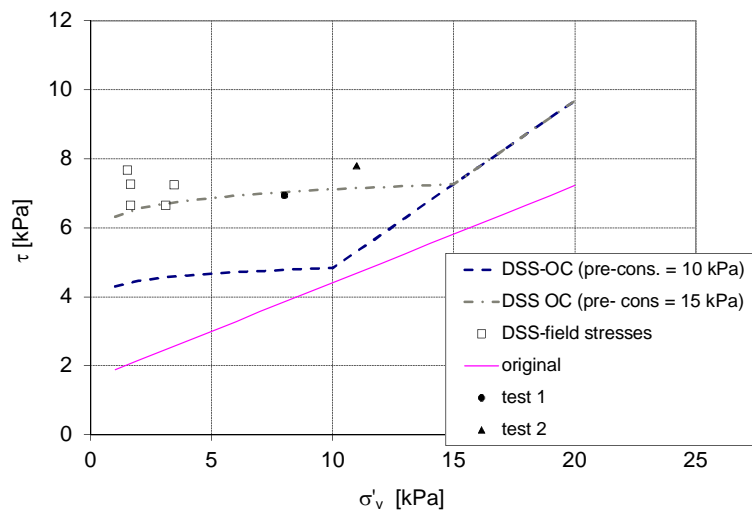
Comparison of test results to field and laboratory tests

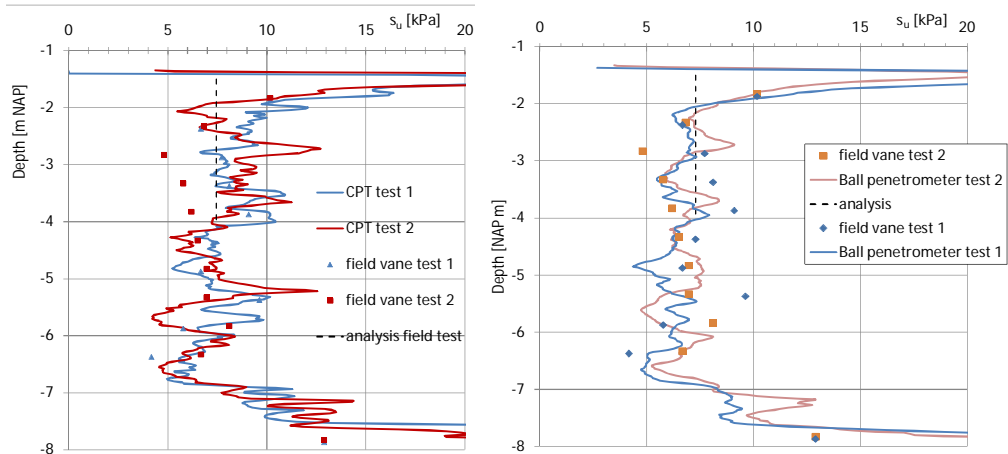
Comparison between field probe test results and analysis
