# Full-scale pullout tests of rock anchors in limestone testing rock mass uplift failure

*Bjarte Grindheim (Bjarte.grindheim@ntnu.no)*

*Department of Geoscience and Petroleum, Norwegian University of Science and Technology (NTNU),  
Trondheim, Norway*

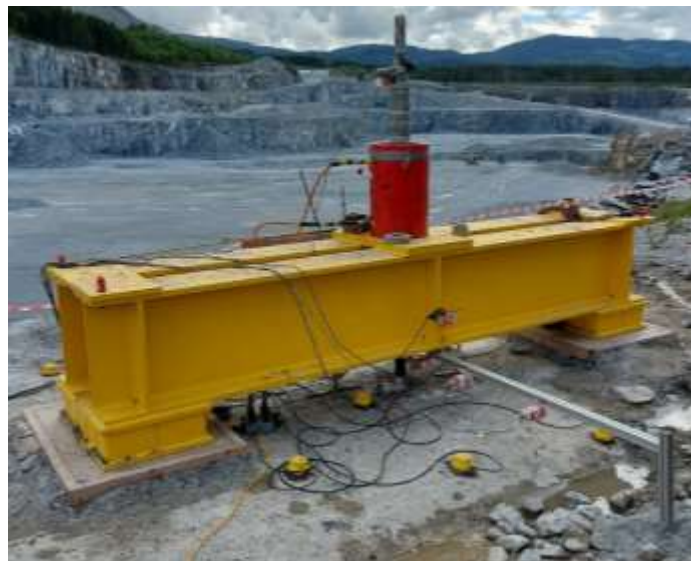
*Figure 2. Test arrangement of anchor A1.5m. The steel beam is placed upon two concrete platforms with a hydraulic jack on top on the anchor. The LVDTs on the aluminium beam measured the surface heaving of the rock mass and the yellow geophones measured the microseismic activity during the test.*

The test arrangement of anchor A1.5m is shown in Figure 2. The beam was placed on two concrete platforms with the anchor in centre. A 3500-kN hydraulic jack was placed on top of the anchor and beam, the area in centre of the beam was fortified with a 5 cm thick steel plate. The hydraulic jack was pressurised from a gasoline driven hydraulic pump and a booster unit with capacity of 700 bar.

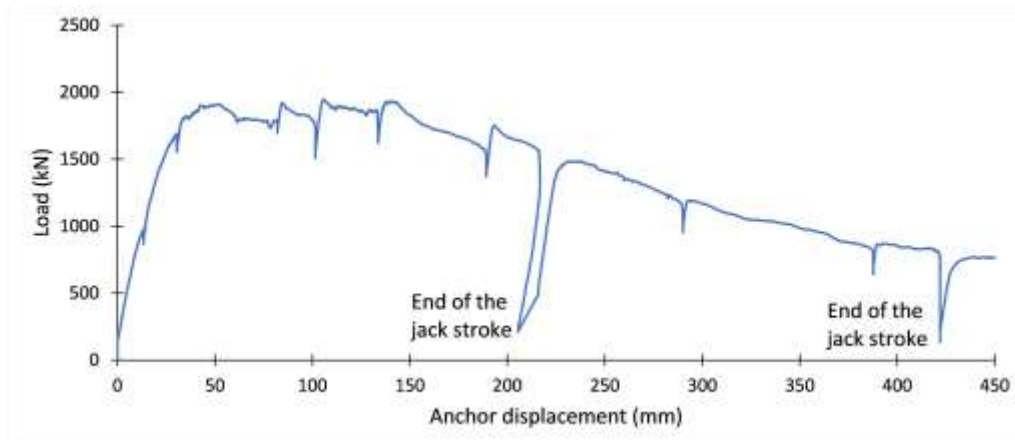
Figure 3. Load-vertical displacement curve of anchor B1.5m. The load drops at 210 mm and 420 mm displacement marks the end of the jack stroke.

The test results are summarised in Table 1 for all the tests. The results from the test of anchor B1.5m is shown more in detail, but the results from the other tests were similar. The load and displacement curve of the anchor is shown in Figure 3. The load increased linearly in the beginning (i.e., elastic stage), then it started to bend (i.e., plastic stage) before reaching the peak load. After peak load, the load dropped gradually, the drops at 210 mm and 420 mm marks the end of the jack stroke. The rock mass surface heaving around anchor B1.5m is shown in Figure 4. The surface heaving of all the anchors was approximately 10% of the anchor displacement closest to the anchor until 200 mm displacement, then it increased to 15-20% of the anchor displacement for the remaining of the tests. The heaving decreased with distance from the anchor.

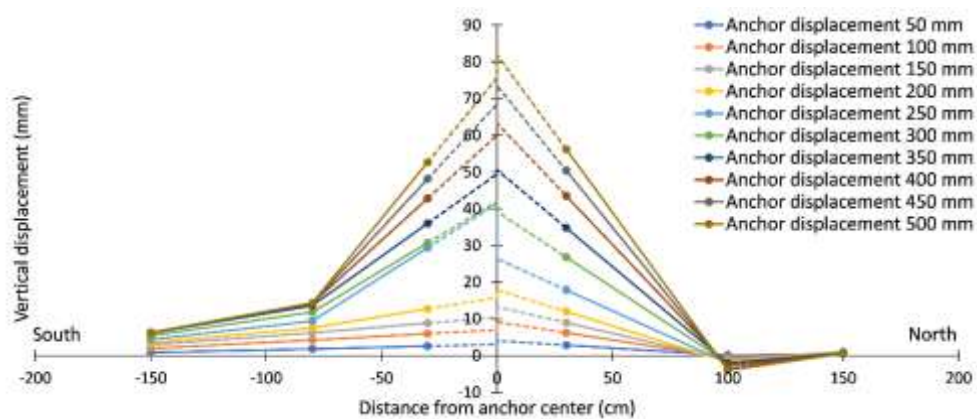
Figure 4. Rock mass surface heaving around anchor B1.5m at distance, where the dotted lines are extrapolations.

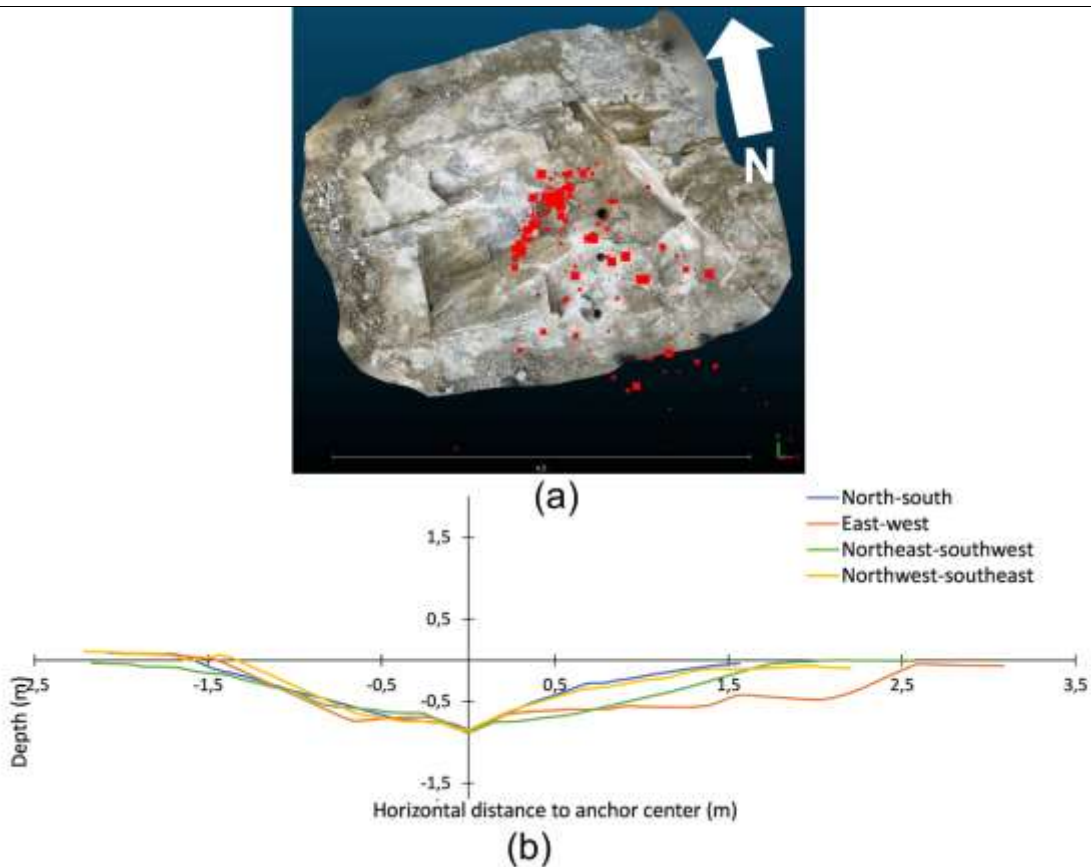
Figure 6. Lidar and seismic data: (a) Lidar scan of failure surface around anchor B1.5m with the location of the seismic events; (b) profiles of the failure surface. The relative size of the seismic events is shown by the size of the dots.

The lidar scan of the failure surface combined with the location of the seismic events and profiles along the failure surface are shown in Figure 6. The seismic events are plotted in the north-east plane with all events on the surface, as depth measurements were unreliable since all the geophones were placed on the surface. The profile in the east-west direction was longer as two of the joint sets in the rock mass formed a wedge in that direction, the failure surfaces of all the tests had this asymmetrical shape with a wedge formed in that direction. The average apex angle was measured from the profiles (Figure 6(b)), for anchor B1.5m the apex angle was 132°. The results from all tests are summarised in Table 1.

The failure mode of the rock mass is complex. The failure shape is also affected by the pre-existing joints in the rock mass. During the tests, it was obvious that the pre-existing joints opened first, as shown in Figure 9. From the seismic measurements in Figure 6, the most part of the failure crater has been developed along the pre-existing joints. There are no or only very small events in the west, northwest, and north side of the crater, which indicate that the intact rock has not fractured in these parts. The colour of the failure surface of these parts are also slightly miscoloured which indicate weathering, which means that these are pre-existing joints in the rock mass.

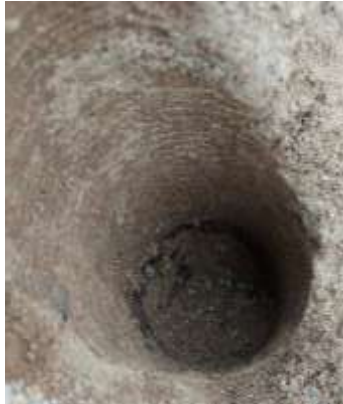
Figure 7. Intact borehole at the bottom of the failure crater after anchor B1.5m.

The failure mode seen in these tests was a combination of rock mass failure and bond failure between grout-rock. The deepest parts of the bonded length had interfacial bond failure between grout-rock. This was observed when the failure surface was cleaned, then the lowest part of the borehole was still intact in the rock mass as shown in Figure 7. Weerasinghe and Littlejohn (1997) also observed combination of rock mass failure and bond failure in weak mudstone. They suggested that the apex lies within the top 0.5 m of the fixed anchor, and that bond failure occurs below 0.5 m depth, which is a possible explanation for the observed failure in these tests since the depth of the failure was consistent between 0.59-0.83 m even though the bonded lengths varied between 0.9-1.4 m depth. Another explanation is due to the measured apex angles, since the angles were wider than what is shown in literature, then the area affected by the tests were wider than the length of the beam. This resulted in the beam

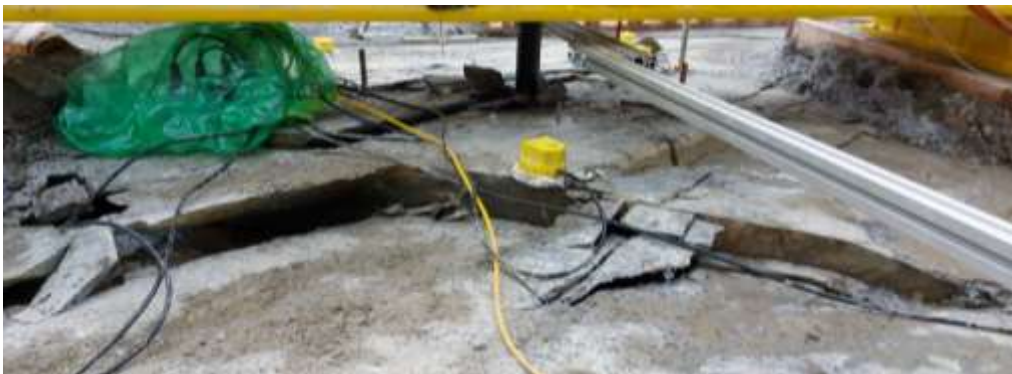
Figure 9. Surface cracking around anchor B1.5m after the test finished.
