MULTI-TECHNIQUE CHARACTERIZATIONS OF MARBLE STONES FROM ELEFSIS, GREECE, AND SOAPSTONES FROM GRYTDAL, NORWAY IN ACCELERATED ACID WEATHERING STUDIES

Kidane Fanta Gebremariam⁽¹⁾, Panagiotis Perakis⁽²⁾, Christian Schellewald⁽²⁾, Theoharis Theoharis⁽²⁾ and Lise Kvittingen⁽¹⁾

Presented at: 18th Edition of Euroanalysis, 06-10 September, 2015, Bordeaux, France Contact e-mail: fanta@ntnu.no

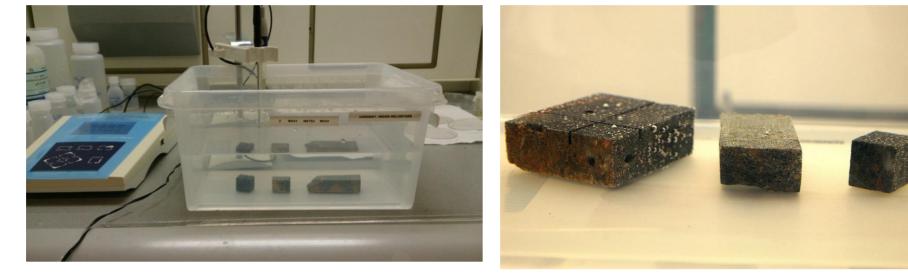
During pH monitoring and adjustment

Non-weathered Grytdal stones when in acidic solution after oven drying. Evolution of gas is noticeable. More enhanced in the weathered one..

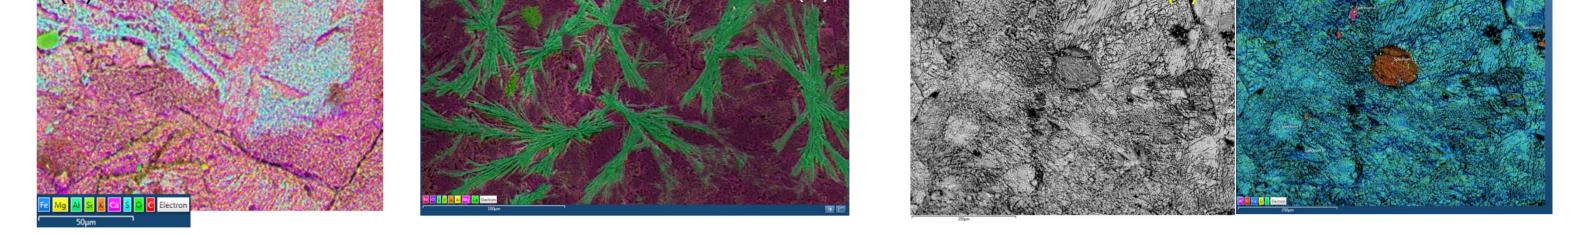
Layered elemental mapping of the surface of E in sulphuric acid solution showing the gypsum on the calcite after the second round (a). The dominant mechanism seems formation of gypsum and subsequent dissolution leading to weight loss. Layered mapping of the surface of NB stone in sulphuric acid solution after the first round (b). The deposition of gypsum crystals associated with the actinolite-thremolite grains that serve as source of the calcium is observed (b). The BSE image and layered mapping of E stone in a mixed nitric and sulphuric acid solution. As the surface is eroded grains of quartz were exposed that leave small dents when they are lost (c).

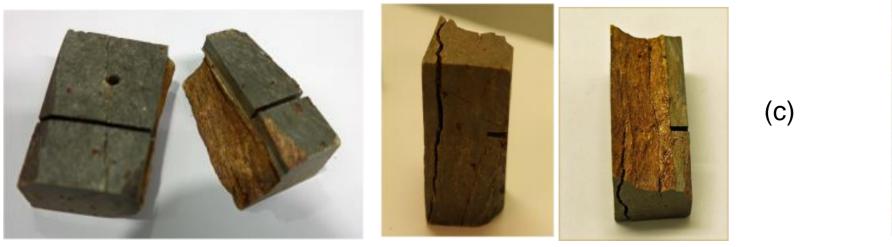
(a) Close up images of NB stones in acid mixtures in the first round with increasing cracking and enhanced eroding of iron sulfide, dolomite and iron oxide rich site (b) Iron oxide rich localities emerging and eroding faster than other parts in NB stone in sulphuric acid solution. They got yellowish\orangish in colour. The cracking gets enhanced leading to volume expansion and eventually detachment. The white precipitations are gypsum confined to selected localities.

(c) NB stones in a mixed acid solution disintegrating, flacking and cracking along layers in the second round. The porosity of the stone in terms of the number, type, size of the pores as well as fissures and cracks matter. The most porous of the three samples NB was much more seriously. An increase in volume was also noted despite high loss in mass.
(d) Formation of yellowish red spots on NG stones in sulphuric acid solution
