Accelerated Salt Weathering Studies on Marble Stones from Elefsis, Greece, and Soapstones from Grytdal, Norway

Accelerated salt weathering setup

Highlights of some of the results

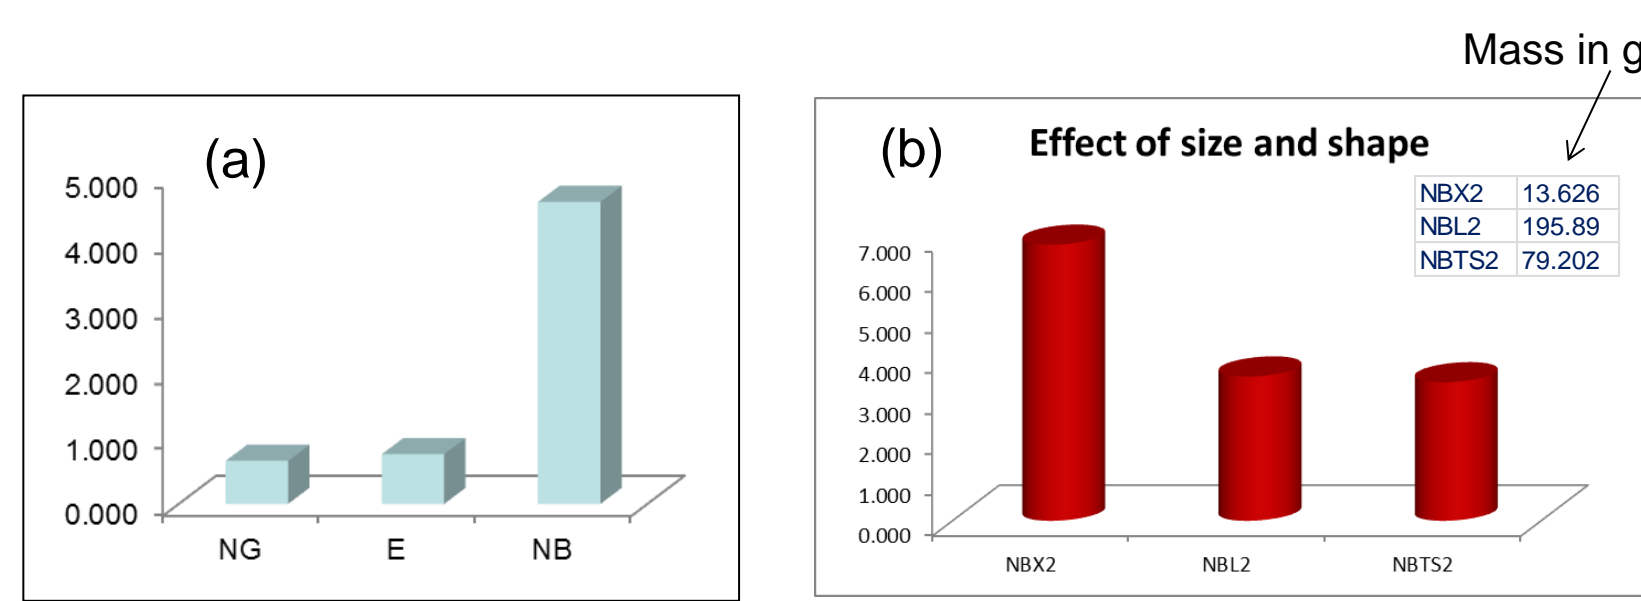
NG – Soapstone not weathered NB- Already weathered soapstone E- Marble

(a) Average percentage change in mass of the three types of stones observed after the first weathering running for a month (b) Effect of the size and shape of three different samples from the more weathered soapstone sample (labelled as NB) in (a)
