D3.3 – Second differential scan data of degrading surfaces

Project Ref. No.	FP7-ICT-2011-9 – FP7-600533
Project Acronym	PRESIOUS
Project Start Date (duration)	1 Feb 2013 (36M)
Deliverable Due Date	31 Jul 2014 (M18)
Actual Delivery Date	31 Oct. 2014
Deliverable Leader	Dirk Rieke-Zapp – (BREUCKMANN GMBH)
Document Status	Final
Dissemination Level	PU

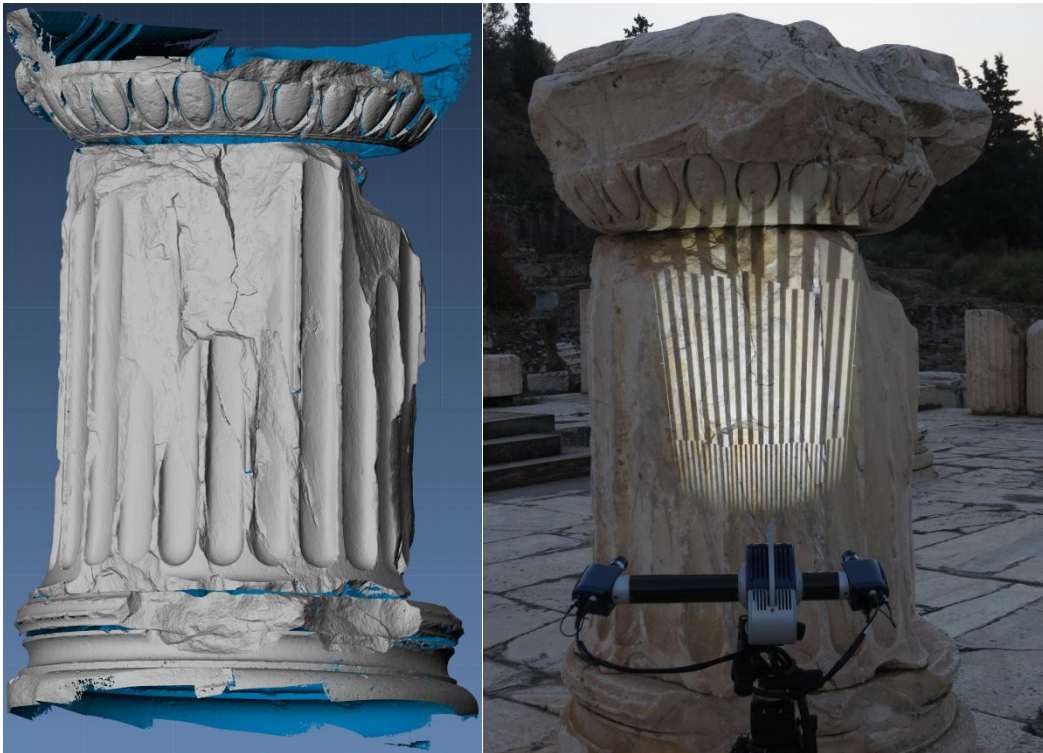
Figure 1. Visualisation of the 3D scanning results from Elefsis in OPTOCAT software (left). Data acquisition with a Breuckmann white light scanning system (right).

In Elefsis a more than 2.2 m tall column drum with a diameter of approximately 1.2 m was scanned (Fig 1.). While only a small area is of interest for the successive erosion scans, the complete column was captured to provide a reference frame for future scans. Overview scans around the column were taken with a large FOV of 850 mm yielding an x,y-resolution of 0.300 mm and a z-resolution (along the viewing direction of the scanner) of 0.016 mm. In total 64 scans were taken and aligned to cover the whole column in this resolution. The part that was already scanned in 2010 and will be evaluated in detail to study erosion within the PRESIOUS project, was captured by 20 additional scans with a FOV of 400 mm yielding a nominal z-resolution of 0.007 mm. All scans were aligned using edge alignment. The resulting model of the complete column represents a very large data set at highest resolution. The data is also available at different levels of detail. The analysis takes place on subsets of the data in order to increase the speed of analysis, viewing and processing. Scans were taken after sunset to ensure optimum contrast of the projected pattern required for white light and stereo-metric scanning.

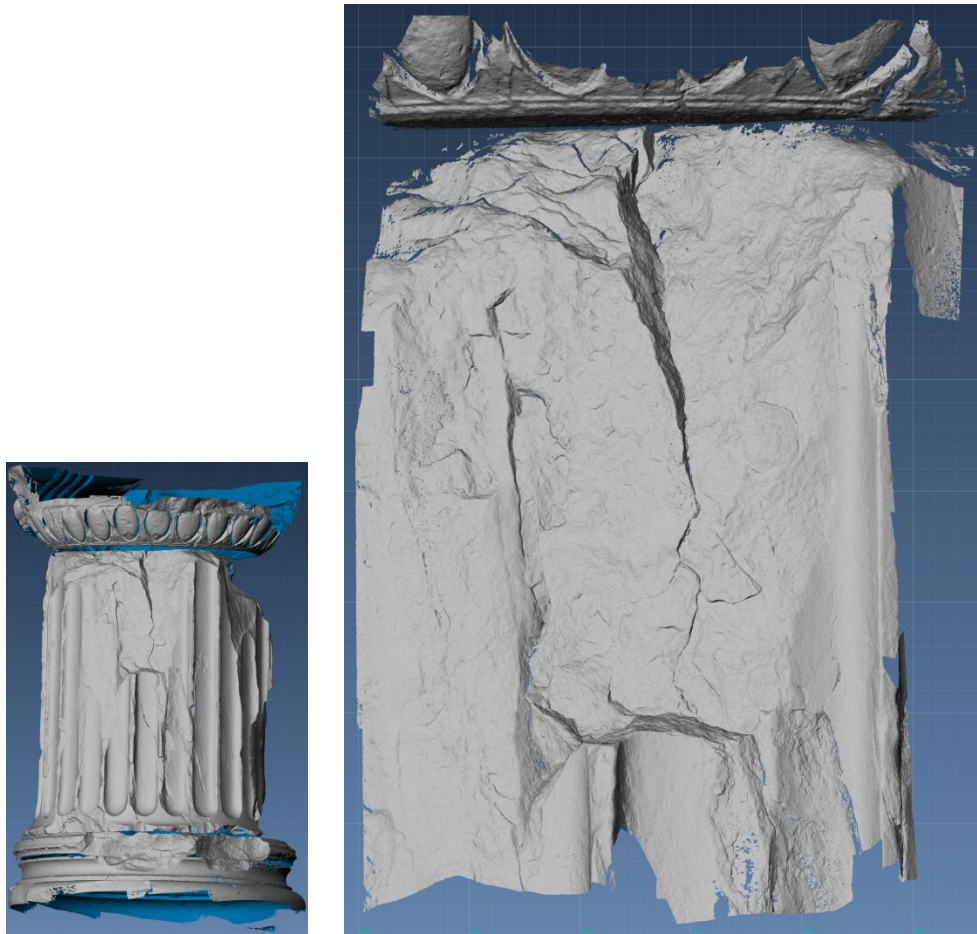
*Greece, Elefsis, **pillar**, acquired 14.10.2014. Overview scan (left) and detail scan (right).*
