Hello everyone, today I'm going to give you a tour on Khobi-II, which in reality pronounced Jobi, and as you know is a hydropower plant located in Georgia.

I'm the deputy project manager for this project that started back in February 2021.

Khobi-II is a run-off-the-river hydropower project, that starts with an intake on the river Khobi.

Let's get into business, and let's talk about the Technical Challenges we have been facing as Owners Engineers*

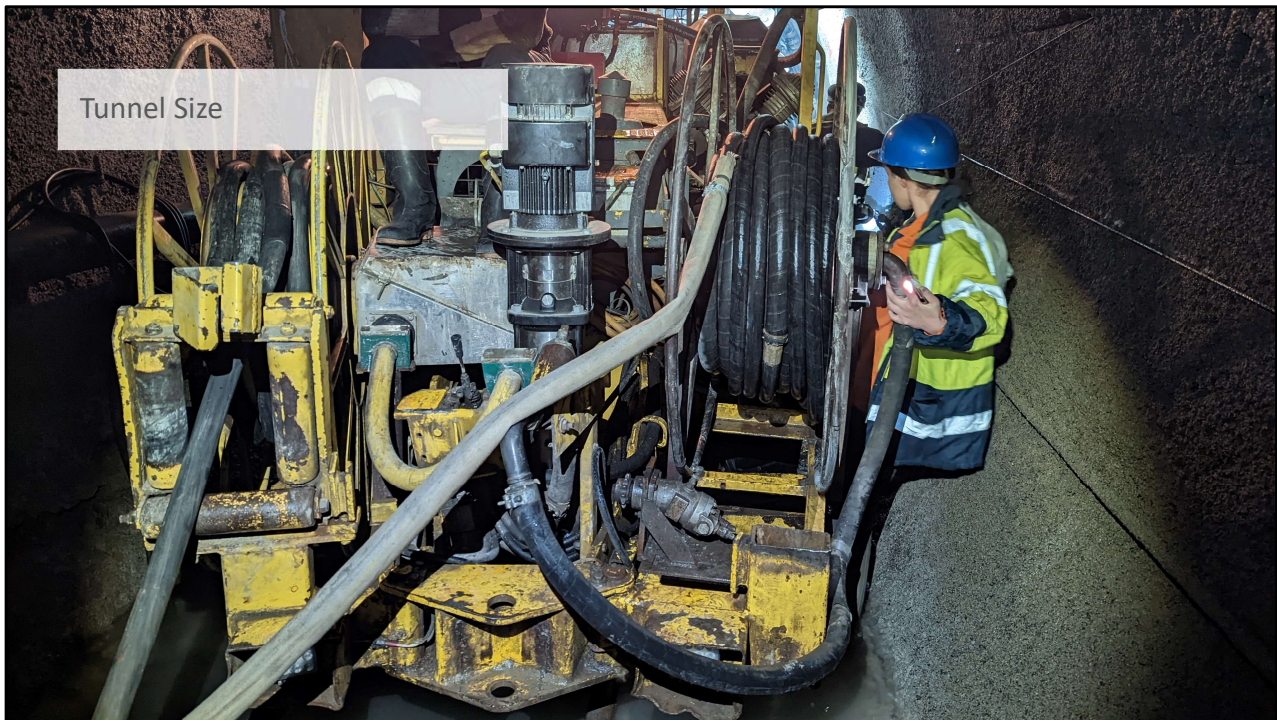
Considering the machinery and all what's happening, it is tiny and doesn't leave space for much.

Here we can see the H&S staff trying to get to the other side of the machine and... *

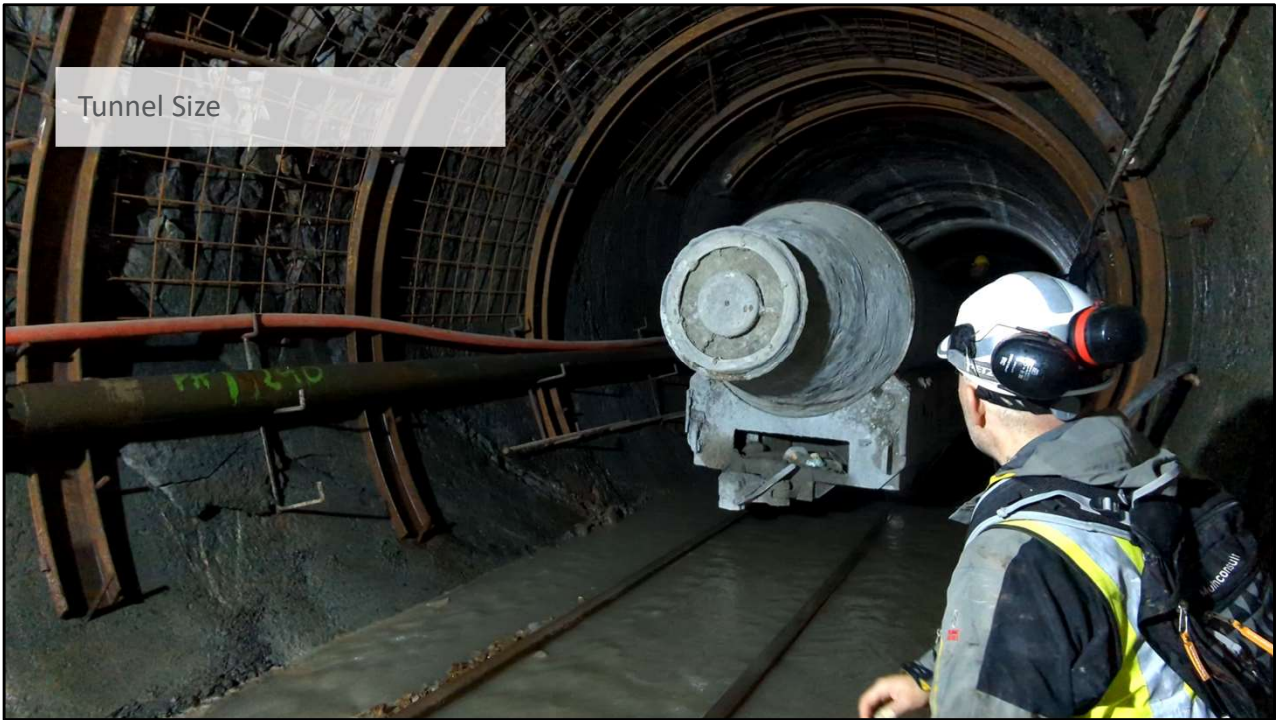
This is, for example, a shotcrete torpedo arriving to the shotcrete robot.

As is possible to see, the space is pretty tight.

But ok, is small, so what's the big deal? Well, everything becomes more difficult to properly execute, from the installation of rockbolts to shotcreting. *

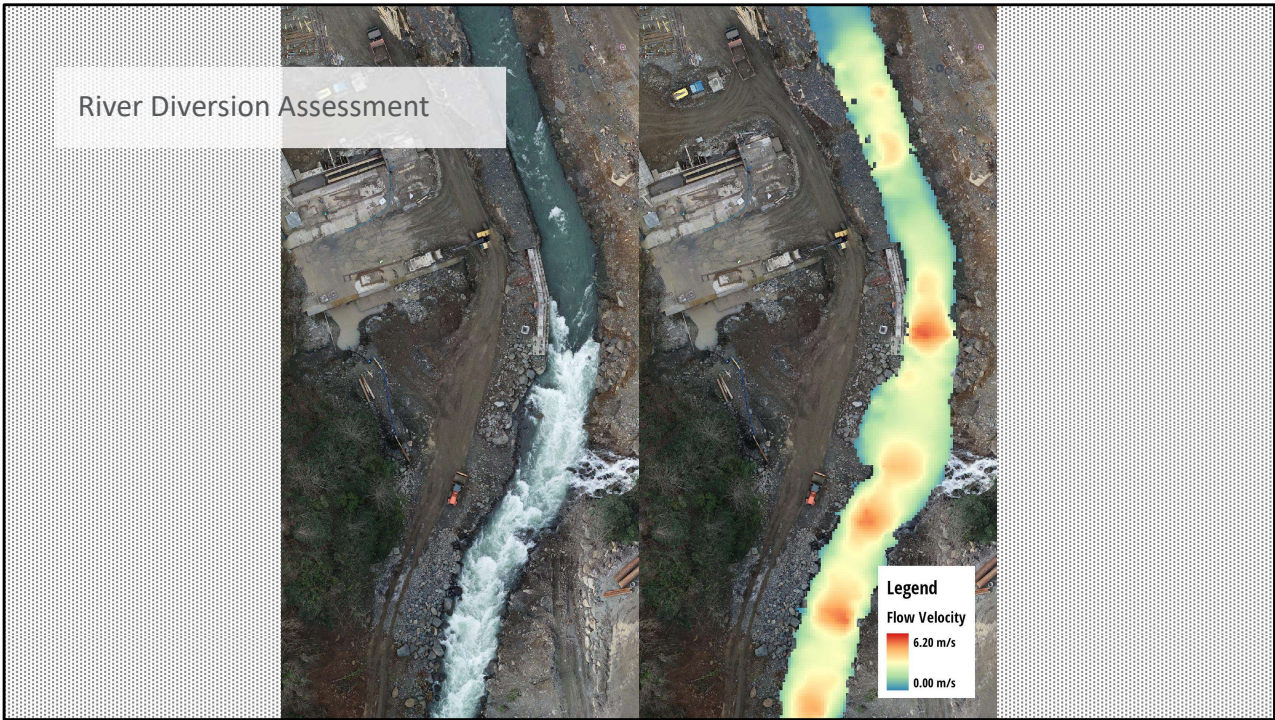
When the model was built and run, we visually compared the results with the orthophotos available, and luckily for us, they made a lot of sense as you can see here.

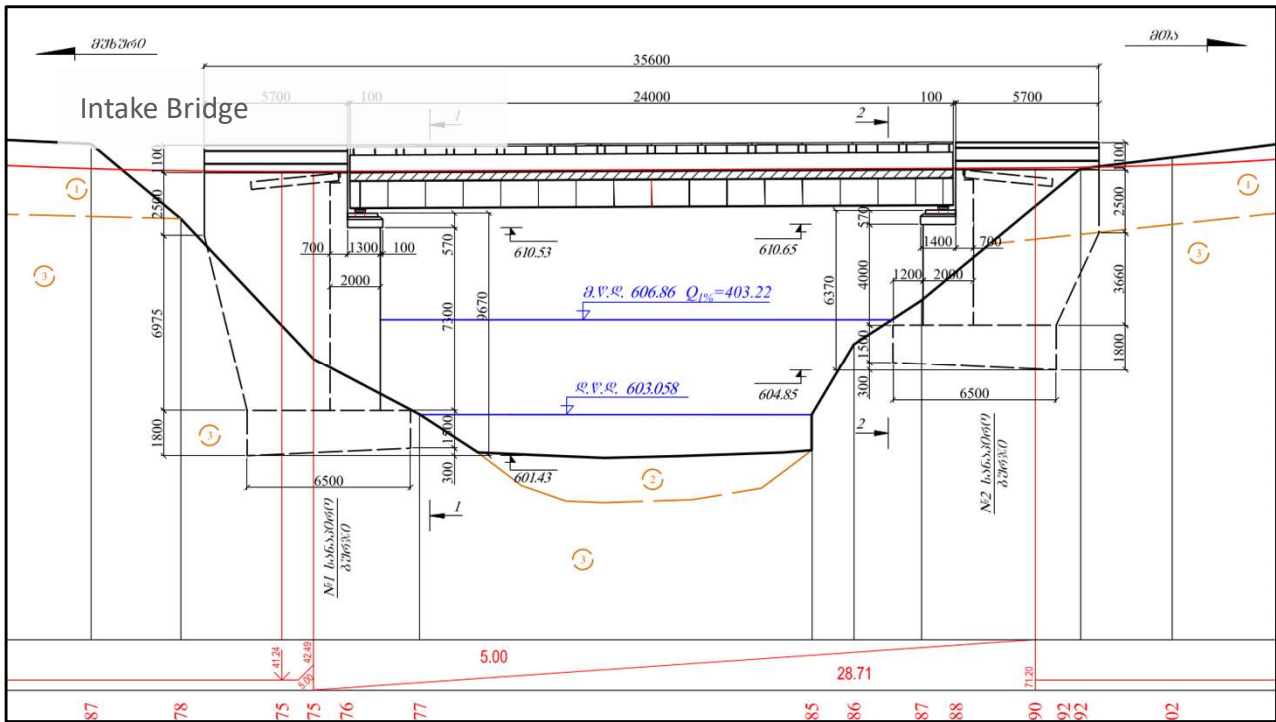
These are the average water level in the river and the 100 years flood event water elevation according to the bridge designer*

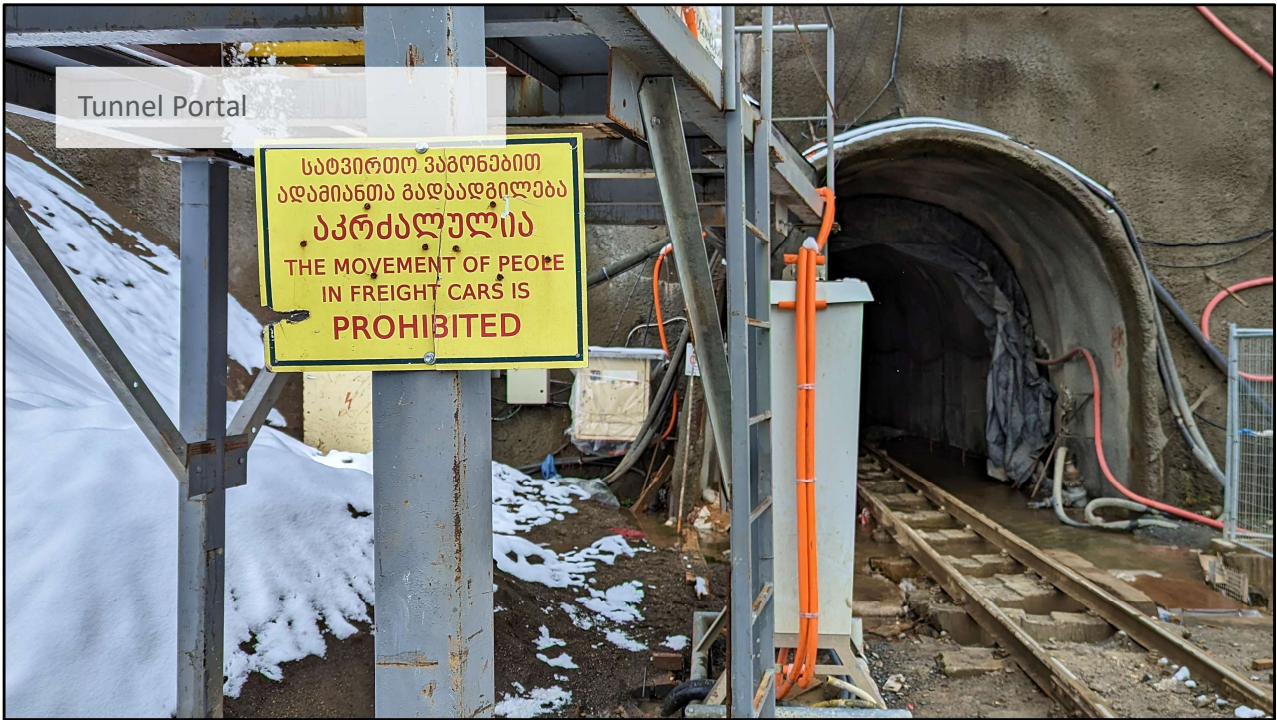
In the tunnel portal, we can find this sign which has been there since the project started:

“The movement of people in freight cars is PROHIBITED”*

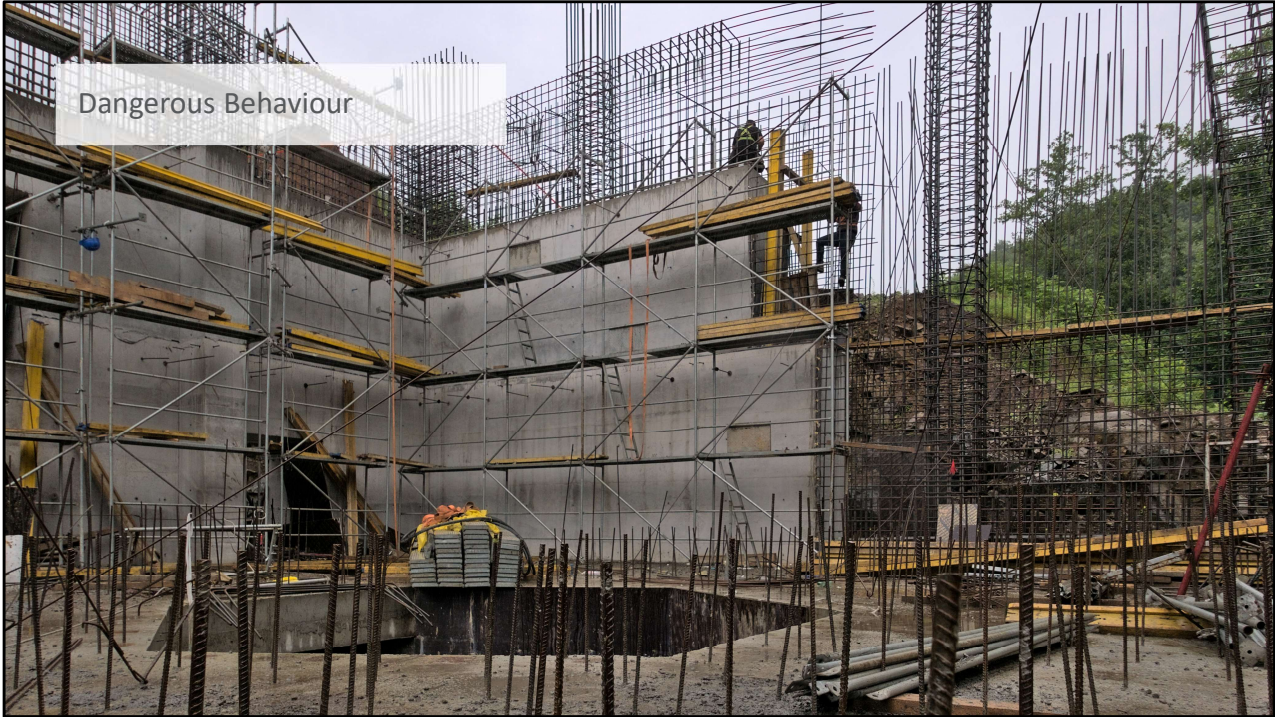
That the Contractor staff likes to do some dangerous activities, the result could be catastrophic.
