PROCESS-RELATED RISKS IN REFURBISHMENT OF DWELLINGS USING PREFABRICATED WALL ELEMENTS WITH INTEGRATED PV AND VENTILATION DUCTS

Norway: Haugerudsenteret 17-19

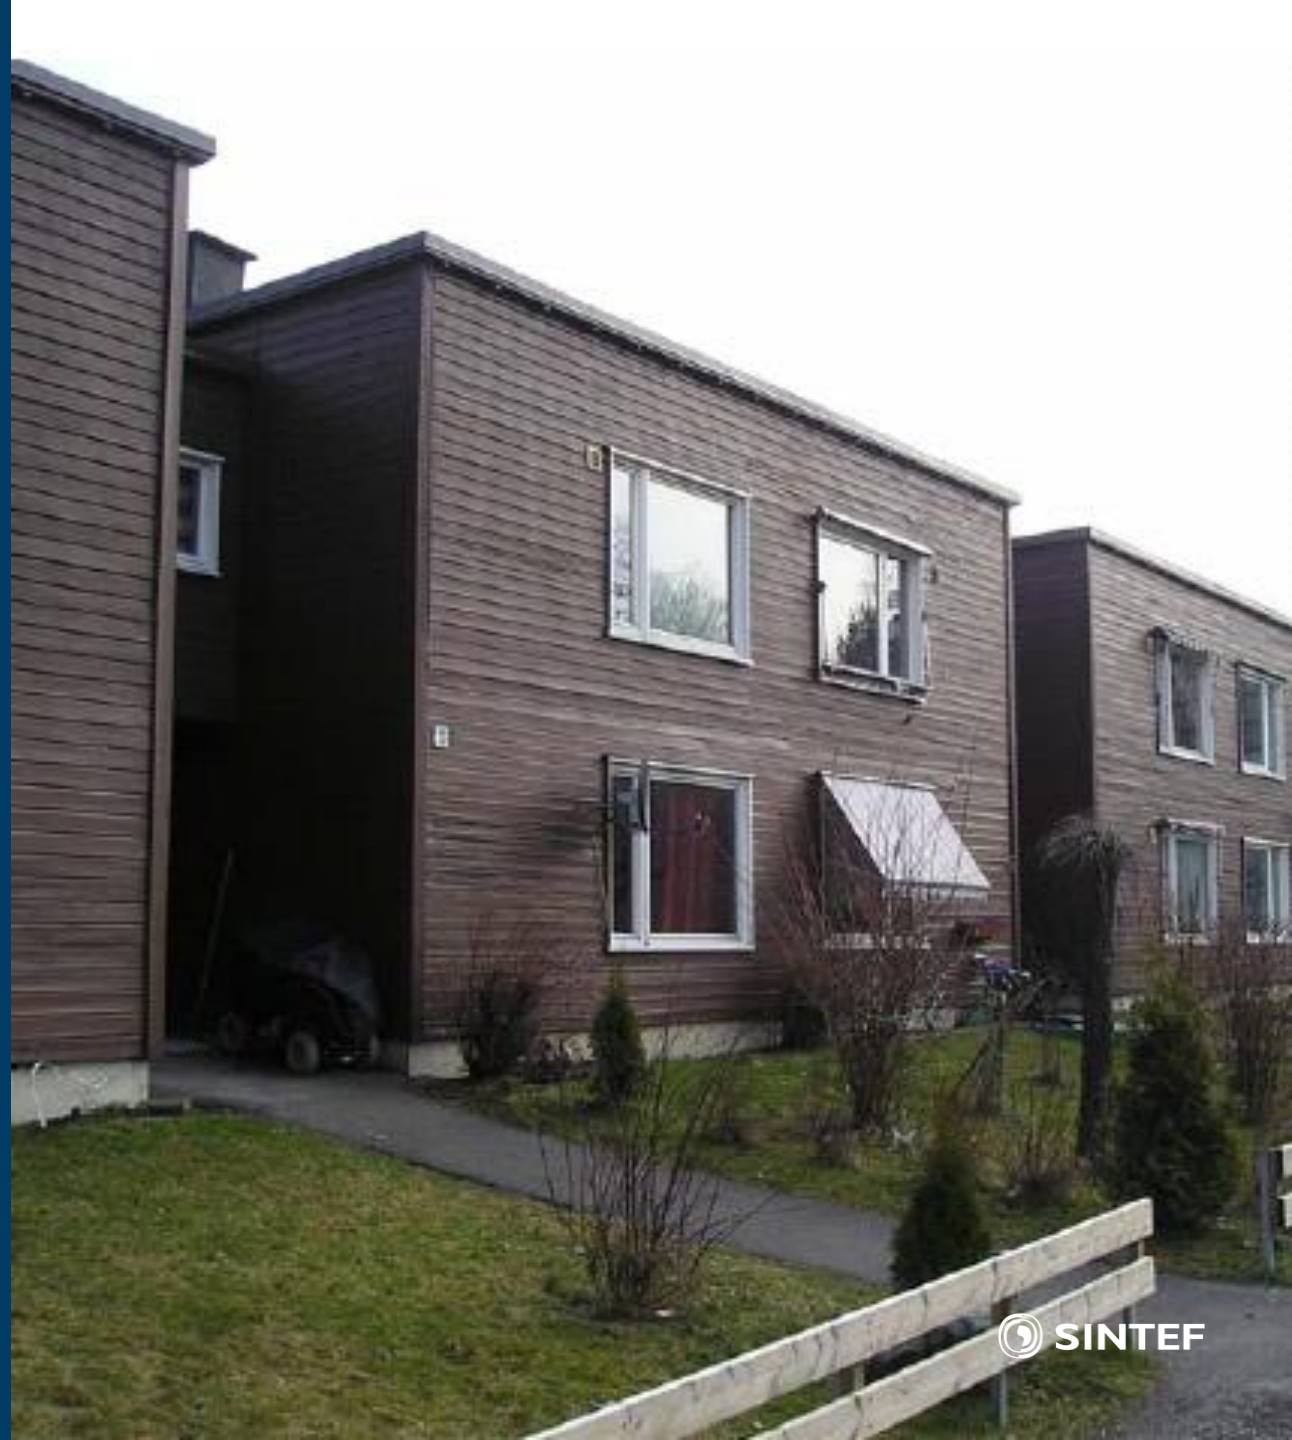
- Owned by Boligbygg, Oslo municipality
- Two floor apartment building from 1971
- Total 8 dwellings, ca 40 m²
- Electric heating
- Natural ventilation
- Small and easy building
- Social housing- Robust solutions needed

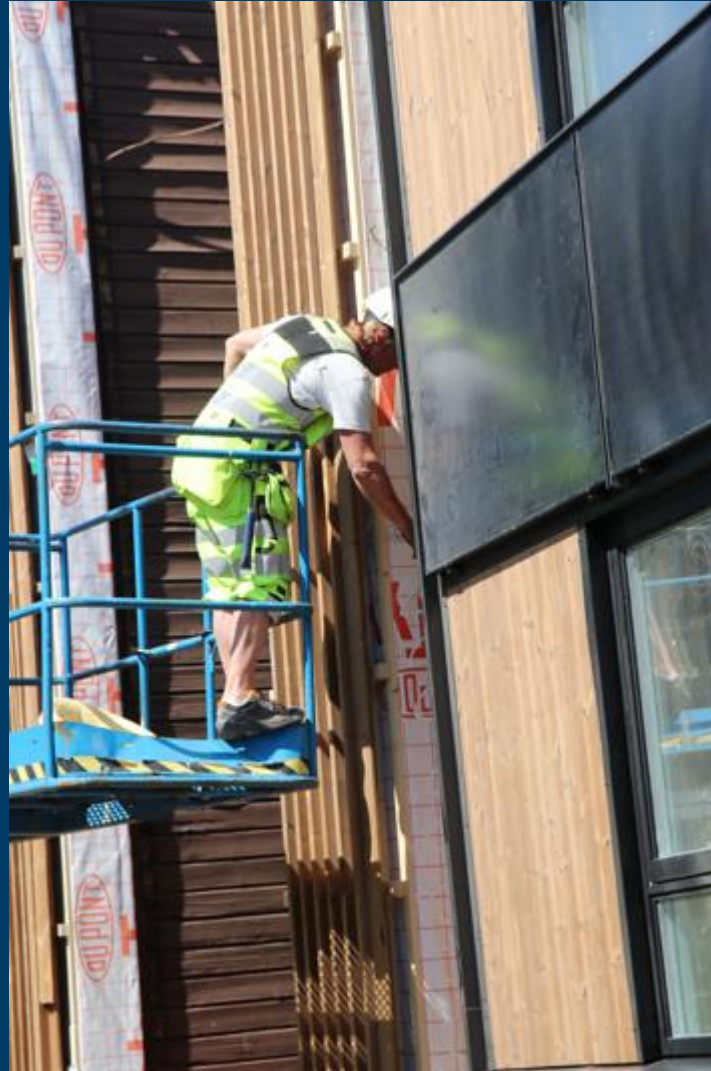
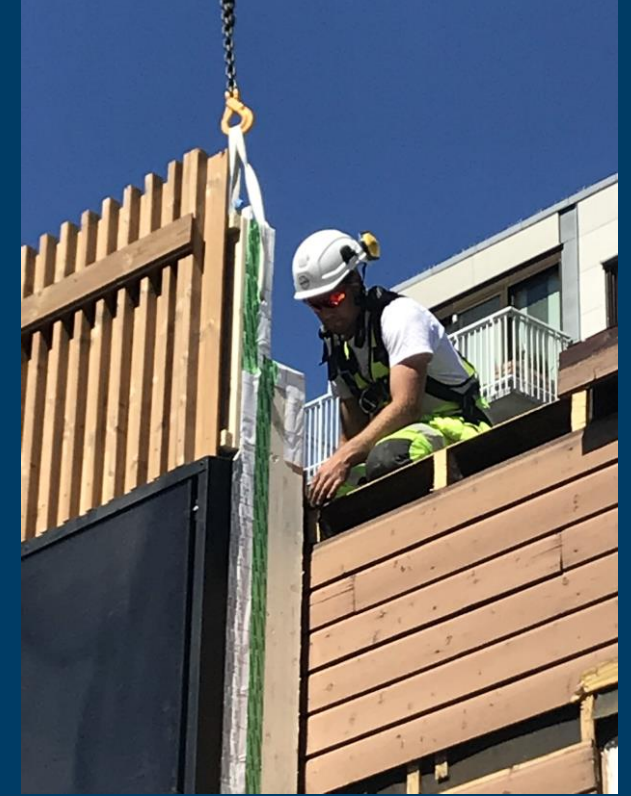
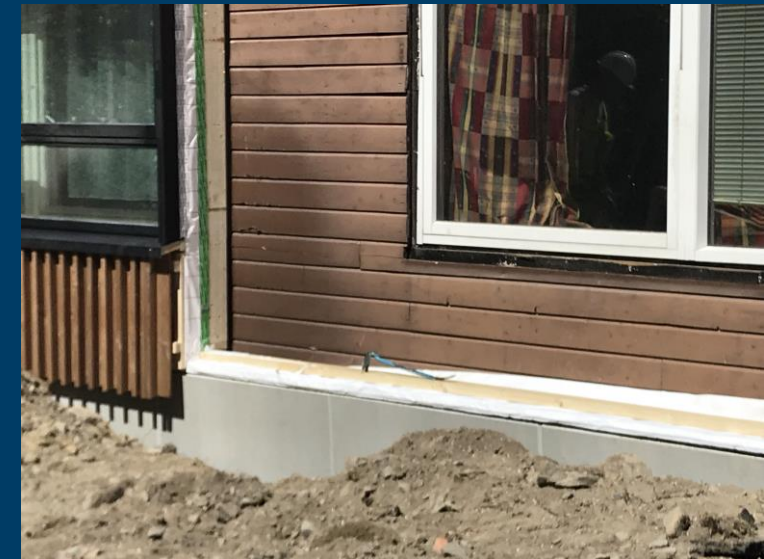
Important details:

- Tolerances
- Joints
- Connection old and new constructions
- Fit to existing openings
- Integration of PV
- Integration of ducts and joints
- Able to produce, transport and install by crane
- Prefabrication = early decisions and orders
- Tenant safety
